# Access Compliance Report

## Public Rights-of-Way

### (Curb Ramps)

Intersection ID: 26208	Main Street: BALLANTRAE VILLAGE DR	Cross Street: ELM LN	Location: SE
ADA ID: 27E1C68FF3A0	Ramp Type: MedianPerp	Initial Pass/Fail: Fail	Overall Compliance: No
Severity Score: 33.75			
Codes/Mitigation Info/Possible Solution		Field Measurements/Component Compliance

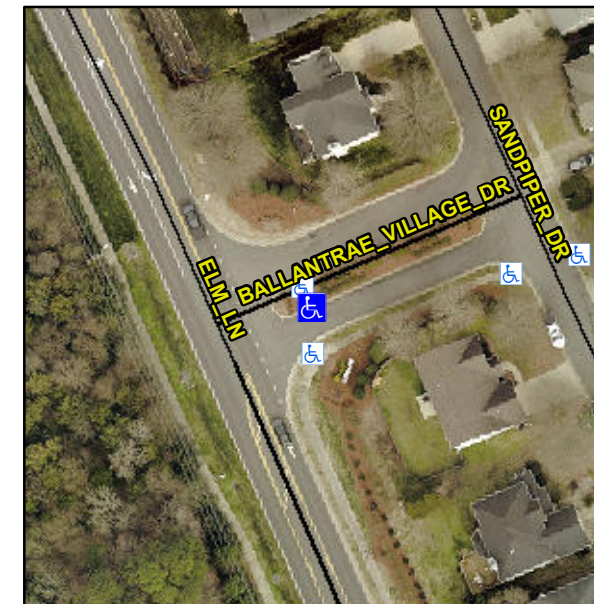
**Not Found, R304.5.1, R304.5.3**

Compliance	Description	Data	Compliance	Description	Data
N/A	Ramp Length (in)	69.0	Yes	Ramp Slope (%)	7.6
No	Ramp Width (in)	46.0	No	Ramp XSlope (%)	7.1
N/A	Flare Type LT	N/A	N/A	Flare Type RT	N/A
N/A	Flare Slope LT (%)	N/A	N/A	Flare Slope RT (%)	N/A
N/A	Flare Traversable LT?	N/A	N/A	Flare Traversable RT?	N/A
N/A	Landing Length (in)	N/A	N/A	DWS Provided?	N/A
N/A	Landing Width (in)	N/A	N/A	DWS Contrast?	N/A
N/A	Landing Slope (%)	N/A	N/A	DWS Length (in)	N/A
N/A	Landing X Slope (%)	N/A	N/A	DWS Full Width?	N/A
N/A	Landing Curb? (Y/N)	N/A	N/A	DWS Offset (in)	N/A
N/A	Shared Landing?	N/A			
N/A	Gutter Ponding?	N/A	N/A	Gutter Slope (%)	N/A
N/A	Gutter Lip Ht (in)	N/A	N/A	Gutter X Slope (%)	N/A
N/A	Painted X Walk1?	No	N/A	Painted X Walk2?	N/A
	X Walk 1 Direction	To S		X Walk 2 Direction	N/A
N/A	X Walk 1 Width (in)	N/A	N/A	X Walk 2 Width (in)	N/A
	X Walk 1 Slope (%)	1.9		X Walk 2 Slope (%)	N/A
	X Walk 1 X Slope (%)	6.6		X Walk 2 X Slope (%)	N/A

N/A	Ramp inside XWalk1?	N/A	N/A	Ramp inside XWalk2?	N/A
	Road Slope (%)	N/A	N/A	Clear Space?	N/A
	Road X Slope (%)	N/A	N/A	Clear Space to XWalk (in)	N/A
N/A	Any Obstructions?	N/A	N/A	Storm Grate/Utility Hazard?	N/A
	Obstruction Type			Storm Grate/Utility Type	
		N/A			N/A
			Yes	Surface Condition? (G/P)	Good

**Remove & Replace Entire Ramp.**

Total Cost: \$ 1650.00
