# Access Compliance Report

## Public Rights-of-Way

### (Curb Ramps)

Intersection ID: 30200	Main Street: BIESTERFIELD_DR	Cross Street: SLATER_SPRINGS_DR	Location: NW
ADA ID: 27E1E7A93B6C	Ramp Type: Perp	Initial Pass/Fail: Fail	Overall Compliance: No
			Severity Score: 13.75

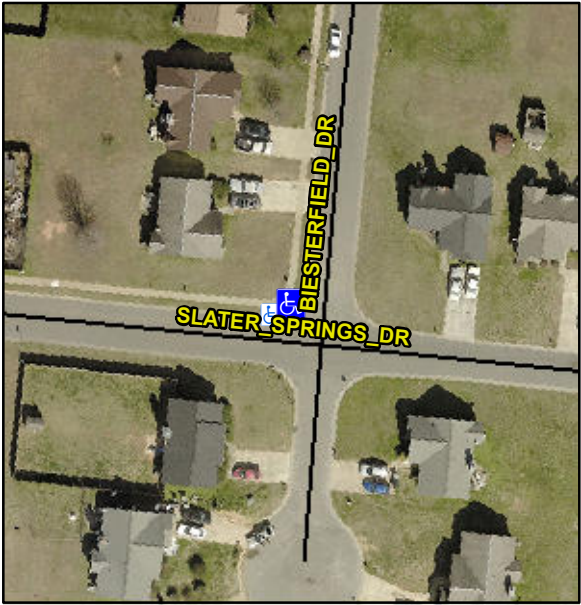
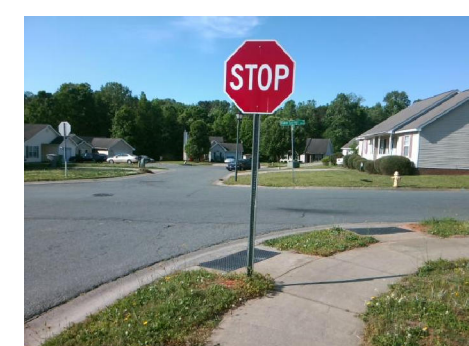
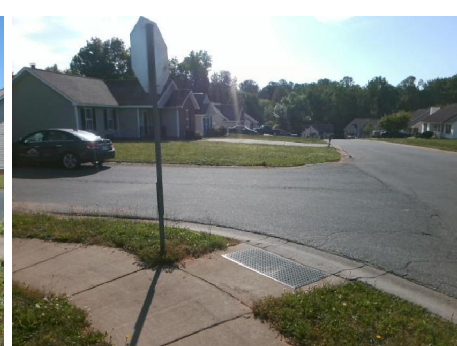
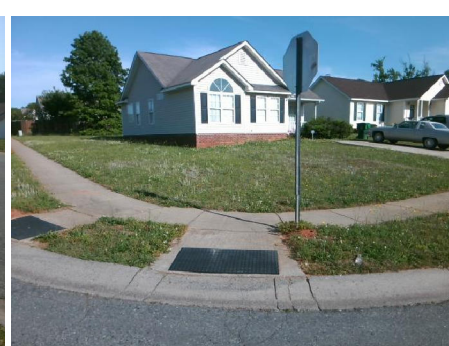
Possible Solutions:		<b>Compliance</b>	<b>Description</b>	<b>Data</b>
	<b>Remove &amp; Replace Entire Ramp.</b>		<b>No</b>	Ramp Length (in)	<b>52.0</b>
			<b>Yes</b>	Ramp Width (in)	<b>48.0</b>
			<b>N/A</b>	Flare Type LT	<b>N/A</b>
			<b>N/A</b>	Flare Slope LT (%)	<b>N/A</b>
			<b>N/A</b>	Flare Traversable LT?	<b>N/A</b>
			<b>N/A</b>	Landing Length (in)	<b>N/A</b>
			<b>N/A</b>	Landing Width (in)	<b>N/A</b>
			<b>N/A</b>	Landing Slope (%)	<b>N/A</b>
			<b>N/A</b>	Landing X Slope (%)	<b>N/A</b>
<p>Surveyor Notes:</p> <p><b>N/A</b></p> <p>PROW/ADA:</p> <p><b>Not Found, R304.2.2, R304.5.3</b></p>			<b>N/A</b>	Flare Type RT	<b>N/A</b>
			<b>N/A</b>	Flare Slope RT (%)	<b>N/A</b>
			<b>N/A</b>	Flare Traversable RT?	<b>N/A</b>
			<b>N/A</b>	DWS Provided?	<b>N/A</b>
			<b>N/A</b>	DWS Contrast?	<b>N/A</b>
			<b>N/A</b>	DWS Length (in)	<b>N/A</b>

<b>N/A</b>	DWS Full Width?	<b>N/A</b>
			<b>N/A</b>	DWS Offset (in)	<b>N/A</b>
			<b>N/A</b>	Gutter Ponding?	<b>N/A</b>
			<b>N/A</b>	Gutter Lip Ht (in)	<b>N/A</b>
			<b>No</b>	Painted X Walk1?	<b>N/A</b>
			<b>To E</b>	X Walk 1 Direction	<b>N/A</b>
			<b>N/A</b>	X Walk 1 Width (in)	<b>N/A</b>
			<b>0.8</b>	X Walk 1 Slope (%)	<b>N/A</b>
			<b>4.4</b>	X Walk 1 X Slope (%)	<b>N/A</b>
			<b>N/A</b>	Ramp inside XWalk1?	<b>N/A</b>
			<b>4.4</b>	Road Slope (%)	<b>N/A</b>
			<b>0.8</b>	Road X Slope (%)	<b>N/A</b>
			<b>N/A</b>	Any Obstructions?	<b>N/A</b>
				Obstruction Type	<b>N/A</b>
Total Cost:			<b>\$ 1850.00</b>		
			<b>N/A</b>		<b>N/A</b>
			<b>Yes</b>	Surface Condition? (G/P)	<b>Good</b>
