Access Compliance Report Public Rights-of-Way (Curb Ramps)

Intersection ID: 30323 Main Street: SHINKANSEN_DR Cross Street: STOURBRIDGE_LION_DR Location: W

ADA ID: 27E50658603F Ramp Type: BlendTrans1 Initial Pass/Fail: Fail Overall Compliance: No Severity Score: 10

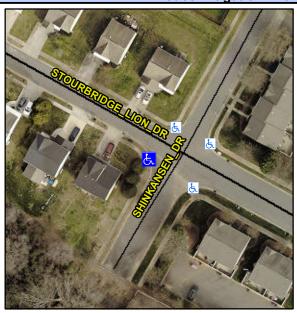
RP < 5%

Not Found, R304.5.1, R304.5.3

Compliance Description Data Compliance Description Data Yes BlendTrans Slope (%) N/A Ramp Length (in) 48.0 4.7 No No Ramp Width (in) 46.0 BlendTrans XSlope (%) 4.6 N/A Flare Type RT N/A Flare Type LT N/A N/A N/A Flare Slope LT (%) N/A Flare Slope RT (%) N/A N/A N/A Flare Traversable LT? N/A N/A Flare Traversable RT? N/A N/A N/A N/A **DWS Provided?** N/A Landing Length (in) N/A Landing Width (in) N/A N/A **DWS Contrast?** N/A N/A N/A Landing Slope (%) N/A DWS Length (in) N/A N/A Landing X Slope (%) N/A N/A DWS Full Width? N/A N/A Landing Curb? (Y/N) N/A N/A DWS Offset (in) N/A N/A N/A Shared Landing? N/A **Gutter Ponding?** N/A N/A Gutter Slope (%) N/A N/A Gutter Lip Ht (in) N/A N/A Gutter X Slope (%) N/A N/A Painted X Walk1? No N/A Painted X Walk2? No X Walk 1 Direction To SE X Walk 2 Direction To NE N/A X Walk 1 Width (in) X Walk 2 Width (in) N/A X Walk 1 Slope (%) 1.2 X Walk 2 Slope (%) 1.5 X Walk 1 X Slope (%) 3.6 X Walk 2 X Slope (%) 2.6 N/A N/A Ramp inside XWalk2? N/A N/A Ramp inside XWalk1? Road Slope (%) 3.4 Clear Space? N/A Road X Slope (%) N/A Clear Space to XWalk (in) N/A 1.6 N/A N/A N/A Any Obstructions? Storm Grate/Utility Hazard? N/A Obstruction Type Storm Grate/Utility Type N/A N/A

Remove & Replace Curb Ramp With Two New Directional Ramps or Equivalent.
