Access Compliance Report Public Rights-of-Way (Curb Ramps)

Intersection ID: 15725Main Street: CLANTON_RDCross Street: S_TRYON_STLocation: NWADA ID: 27E82E9E8FD5Ramp Type: PerpInitial Pass/Fail: Fail Overall Compliance: No Severity Score: 25

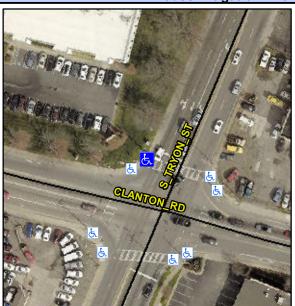
Possible Solution		Field Measurements/Component Compliance					
Possible Solutions:	Comp	liance Description	Data	Complian	ce Description	Data	
Remove & Replace Entire Ramp.	N/A	Ramp Length (in)	60.0	No R	tamp Slope (%)	8.8	
	Yes	Ramp Width (in)	48.0	No R	tamp XSlope (%)	6.6	
	N/A	Flare Type LT	N/A	N/A F	lare Type RT	N/A	
	N/A	Flare Slope LT (%)	N/A	N/A F	lare Slope RT (%)	N/A	
	N/A	Flare Traversable LT?	N/A	N/A F	lare Traversable RT?	N/A	
	N/A	Landing Length (in)	N/A	N/A D	WS Provided?	N/A	
Surveyor Notes:	N/A	Landing Width (in)	N/A	N/A D	OWS Contrast?	N/A	
N/A	N/A	Landing Slope (%)	N/A	N/A D	WS Length (in)	N/A	
	N/A	Landing X Slope (%)	N/A	N/A	WS Full Width?	N/A	
	N/A	Landing Curb? (Y/N)	N/A	N/A D	OWS Offset (in)	N/A	
	N/A	Shared Landing?	N/A				
PROW/ADA:	N/A	Gutter Ponding?	N/A	N/A G	Sutter Slope (%)	N/A	
Not Found, R304.2.2, R304.5.3	N/A	Gutter Lip Ht (in)	N/A	N/A G	Gutter X Slope (%)	N/A	
	N/A	Painted X Walk1?	Yes	N/A P	ainted X Walk2?	N/A

X Walk 1 Direction	To SE	×	Walk 2 Direction	N/A	
	N/A	X Walk 1 Width (in)	113.0	N/A X	(Walk 2 Width (in)	N/A	
		X Walk 1 Slope (%)	3.6	×	(Walk 2 Slope (%)	N/A	
		X Walk 1 X Slope (%)	8.9	×	(Walk 2 X Slope (%)	N/A	
	N/A	Ramp inside XWalk1?	Yes	N/A F	Ramp inside XWalk2?	N/A	
		Road Slope (%)	N/A	N/A C	Clear Space?	N/A	
		Road X Slope (%)	N/A	N/A	Clear Space to XWalk (in)	N/A	
	N/A	Any Obstructions?	N/A	N/A S	Storm Grate/Utility Hazard?	N/A	
Total Cost: \$ 1850.0	0	Obstruction Type		s	Storm Grate/Utility Type		
			N/A			N/A
