Access Compliance Report Public Rights-of-Way (Curb Ramps)

Intersection ID: 11980 Main Street: ALLEN_ST				Street [.]	E_17TH_ST	Location:	S			
ADA ID: 27EC2DAEB49E Ramp Type: PerpDiag			Initial I	Initial Pass/Fail: Fail Overall Compliance: No					12.5	
Codes/Mitigation Info/Possible Solution				Field Measurements/Component Compliance						
1 AL AVII		Possible Solutions:		Compliance Description			Data Compliance Description		Data	
		Remove & Replace Curb Ramp \	Nith	N/A	Ramp Length (in)	50.0	No	Ramp Slope (%)	8.4	
		Two New Directional Ramps or		Yes	Ramp Width (in)	67.0	Yes	Ramp XSlope (%)	1.4	
		Equivalent.		N/A	Flare Type LT	N/A	N/A	Flare Type RT	N/A	
				N/A	Flare Slope LT (%)	N/A	N/A	Flare Slope RT (%)	N/A	
and the second second				N/A	Flare Traversable LT?	N/A	N/A	Flare Traversable RT?	N/A	
				N/A	Landing Length (in)	N/A	N/A	DWS Provided?	N/A

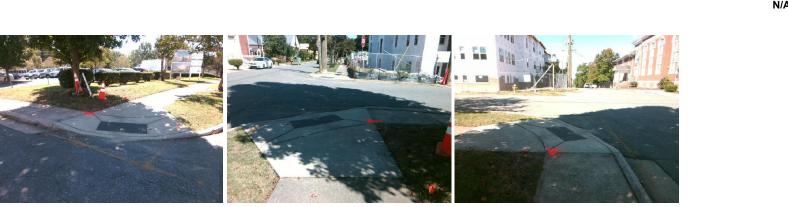
E. OF MILL OF		Surveyor Notes:		N/A	Landing Width (in)	N/A	N/A	DWS Contrast?	N/A	
	and a state	N/A		N/A	Landing Slope (%)	N/A	N/A	DWS Length (in)	N/A	
	and the second s			N/A	Landing X Slope (%)	N/A	N/A	DWS Full Width?	N/A	
	The second			N/A	Landing Curb? (Y/N)	N/A	N/A	DWS Offset (in)	N/A	
PROW/ADA: R304.2.2				N/A	Shared Landing?	N/A				
		PROW/ADA:		N/A	Gutter Ponding?	N/A	N/A	Gutter Slope (%)	N/A	
		R304.2.2		N/A	Gutter Lip Ht (in)	N/A	N/A	Gutter X Slope (%)	N/A	
				N/A	Painted X Walk1?	No	N/A	Painted X Walk2?	No	
					X Walk 1 Direction	To NE		X Walk 2 Direction	To NW	
				N/A	X Walk 1 Width (in)	N/A	N/A	X Walk 2 Width (in)	N/A	
Street 1 Name	E 17TH ST	-			X Walk 1 Slope (%)	2.6		X Walk 2 Slope (%)	2.4	
Stop Condition-Street 2	StopSign				X Walk 1 X Slope (%)	2.7		X Walk 2 X Slope (%)	0.3	
Street 2 Name	ALLEN ST			N/A	Ramp inside XWalk1?	N/A	N/A	Ramp inside XWalk2?	N/A	
Stop Condition-Street 1	None				Road Slope (%)	1.9	N/A	Clear Space?	N/A

Road X Slope (%)	3.7	N/A	Clear Space to XWalk (in)	N/A	
				N/A	Any Obstructions?	N/A	N/A	Storm Grate/Utility Hazard?	N/A	
		Total Cost: \$	3200.00		Obstruction Type			Storm Grate/Utility Type		
						N/A			N/A
