# Access Compliance Report

## Public Rights-of-Way

### (Curb Ramps)

Intersection ID: 53893	Main Street: PERTH_MOOR_RD	Cross Street: HAMILTON_BRIDGE_RD	Location: NW
ADA ID: 27F98DD8E7DB	Ramp Type: Perp	Initial Pass/Fail: Fail	Overall Compliance: No
Severity Score: 8.75			
Codes/Mitigation Info/Possible Solution		Field Measurements/Component Compliance

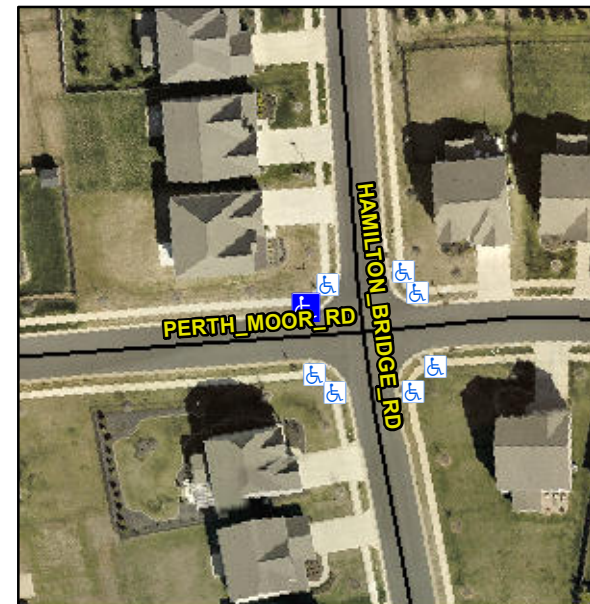
**Not Found, R304.5.1**

Compliance	Description	Data	Compliance	Description	Data
N/A	Ramp Length (in)	50.0	Yes	Ramp Slope (%)	6.7
No	Ramp Width (in)	46.5	Yes	Ramp XSlope (%)	0.9
N/A	Flare Type LT	N/A	N/A	Flare Type RT	N/A
N/A	Flare Slope LT (%)	N/A	N/A	Flare Slope RT (%)	N/A
N/A	Flare Traversable LT?	N/A	N/A	Flare Traversable RT?	N/A
N/A	Landing Length (in)	N/A	N/A	DWS Provided?	N/A
N/A	Landing Width (in)	N/A	N/A	DWS Contrast?	N/A
N/A	Landing Slope (%)	N/A	N/A	DWS Length (in)	N/A
N/A	Landing X Slope (%)	N/A	N/A	DWS Full Width?	N/A
N/A	Landing Curb? (Y/N)	N/A	N/A	DWS Offset (in)	N/A
N/A	Shared Landing?	N/A			
N/A	Gutter Ponding?	N/A	N/A	Gutter Slope (%)	N/A
N/A	Gutter Lip Ht (in)	1.0	N/A	Gutter X Slope (%)	N/A
N/A	Painted X Walk1?	No	N/A	Painted X Walk2?	N/A
	X Walk 1 Direction	To S		X Walk 2 Direction	N/A
N/A	X Walk 1 Width (in)	N/A	N/A	X Walk 2 Width (in)	N/A
	X Walk 1 Slope (%)	1.0		X Walk 2 Slope (%)	N/A
	X Walk 1 X Slope (%)	4.0		X Walk 2 X Slope (%)	N/A

N/A	Ramp inside XWalk1?	N/A	N/A	Ramp inside XWalk2?	N/A
	Road Slope (%)	N/A	N/A	Clear Space?	N/A
	Road X Slope (%)	N/A	N/A	Clear Space to XWalk (in)	N/A
N/A	Any Obstructions?	N/A	N/A	Storm Grate/Utility Hazard?	N/A
	Obstruction Type			Storm Grate/Utility Type	
		N/A			N/A
			Yes	Surface Condition? (G/P)	Good

**Remove & Replace Entire Ramp.**
