Access Compliance Report

Public Rights-of-Way

(Curb Ramps)

Intersection ID: 45182	Main Street: MAPLEHURST_DR	Cross Street: SOCIETY_ST	Location: SE
ADA ID: 27FAD88D4A10	Ramp Type: Perp	Initial Pass/Fail: Fail	Overall Compliance: No
Codes/Mitigation Info/Possible Solution		Field Measurements/Component Compliance	
Severity Score: 12.5

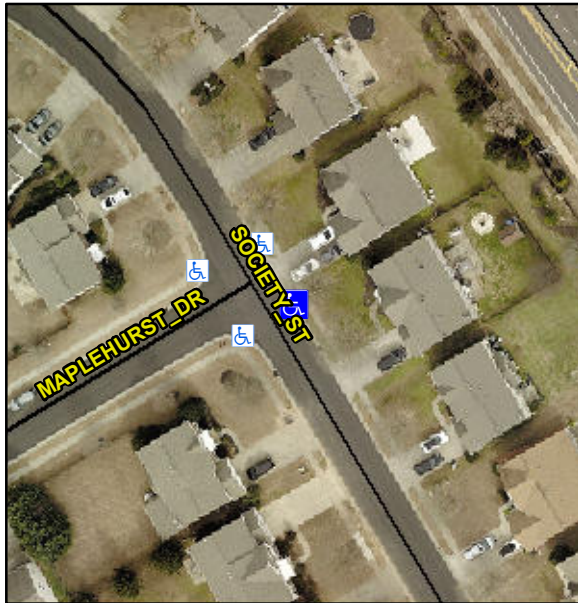
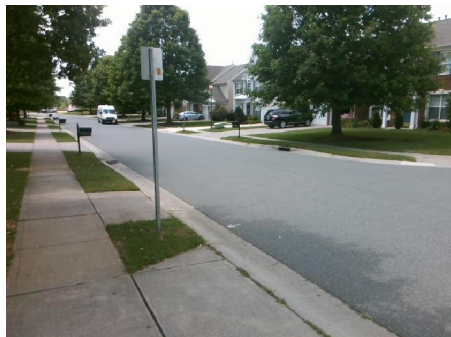
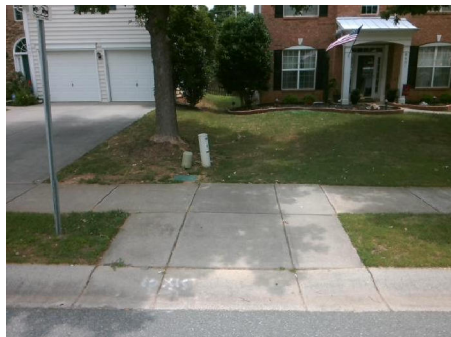
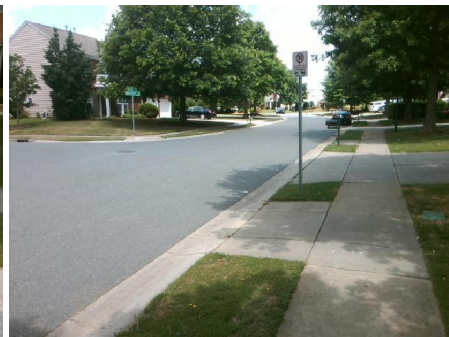
Not Found, R304.2.2

Compliance	Description	Data	Compliance	Description	Data
N/A	Ramp Length (in)	47.0	No	Ramp Slope (%)	11.4
Yes	Ramp Width (in)	49.0	Yes	Ramp XSlope (%)	1.3
N/A	Flare Type LT	N/A	N/A	Flare Type RT	N/A
N/A	Flare Slope LT (%)	N/A	N/A	Flare Slope RT (%)	N/A
N/A	Flare Traversable LT?	N/A	N/A	Flare Traversable RT?	N/A
N/A	Landing Length (in)	N/A	N/A	DWS Provided?	N/A
N/A	Landing Width (in)	N/A	N/A	DWS Contrast?	N/A
N/A	Landing Slope (%)	N/A	N/A	DWS Length (in)	N/A
N/A	Landing X Slope (%)	N/A	N/A	DWS Full Width?	N/A
N/A	Landing Curb? (Y/N)	N/A	N/A	DWS Offset (in)	N/A
N/A	Shared Landing?	N/A			
N/A	Gutter Ponding?	N/A	N/A	Gutter Slope (%)	N/A
N/A	Gutter Lip Ht (in)	N/A	N/A	Gutter X Slope (%)	N/A
N/A	Painted X Walk1?	No	N/A	Painted X Walk2?	N/A
	X Walk 1 Direction	To SW		X Walk 2 Direction	N/A
N/A	X Walk 1 Width (in)	N/A	N/A	X Walk 2 Width (in)	N/A
	X Walk 1 Slope (%)	3.8		X Walk 2 Slope (%)	N/A
	X Walk 1 X Slope (%)	1.9		X Walk 2 X Slope (%)	N/A

N/A	Ramp inside XWalk1?	N/A	N/A	Ramp inside XWalk2?	N/A
	Road Slope (%)	N/A	N/A	Clear Space?	N/A
	Road X Slope (%)	N/A	N/A	Clear Space to XWalk (in)	N/A
N/A	Any Obstructions?	N/A	N/A	Storm Grate/Utility Hazard?	N/A
	Obstruction Type			Storm Grate/Utility Type	
		N/A			N/A
			Yes	Surface Condition? (G/P)	Good

Possible Solutions:

Remove & Replace Entire Ramp.
