# Access Compliance Report

## Public Rights-of-Way

### (Curb Ramps)

Intersection ID: 9305	Main Street: LUCENA_ST	Cross Street: MORETZ_AV	Location: NW
ADA ID: 27FDAE186DD5	Ramp Type: Para	Initial Pass/Fail: Fail	Overall Compliance: No
Severity Score: 12.5			
Codes/Mitigation Info/Possible Solution		Field Measurements/Component Compliance

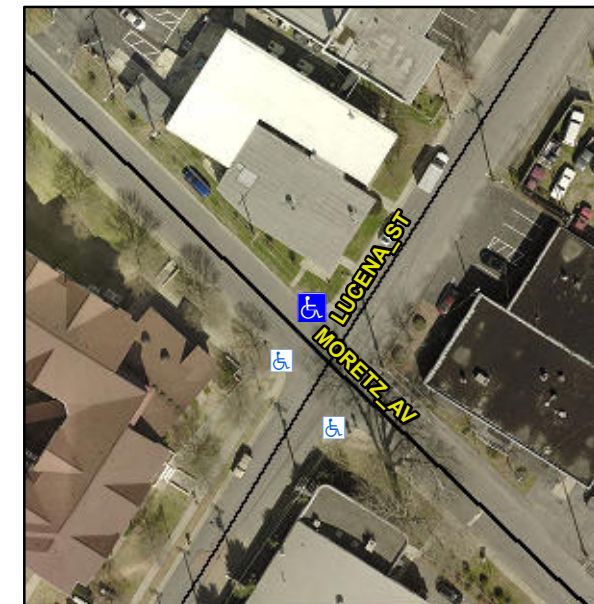
**NO CURB LINE, VEGETATION  
OVERGROWTH, NO LT SW**

**R304.5.3**

Compliance	Description	Data	Compliance	Description	Data
N/A	Ramp Length LT (in)	N/A	N/A	Ramp Length RT (in)	45.0
N/A	Ramp Width LT (in)	N/A	Yes	Ramp Width RT (in)	55.0
N/A	Ramp Slope LT (%)	N/A	Yes	Ramp Slope RT (%)	5.7
N/A	Ramp XSlope LT (%)	N/A	No	Ramp XSlope RT (%)	5.2
N/A	Landing Length (in)	N/A	N/A	DWS Provided?	N/A
N/A	Landing Width (in)	N/A	N/A	DWS Contrast?	N/A
N/A	Landing Slope (%)	N/A	N/A	DWS Length (in)	N/A
N/A	Landing X Slope (%)	N/A	N/A	DWS Full Width?	N/A
N/A	Landing Curb? (Y/N)	N/A	N/A	DWS Offset (in)	N/A
N/A	Shared Landing?	N/A			
N/A	Gutter Ponding?	N/A	N/A	Gutter Slope (%)	N/A
N/A	Gutter Lip Ht (in)	N/A	N/A	Gutter X Slope (%)	N/A
N/A	Painted X Walk1?	No	N/A	Painted X Walk2?	N/A
	X Walk 1 Direction	To SW		X Walk 2 Direction	N/A
N/A	X Walk 1 Width (in)	N/A	N/A	X Walk 2 Width (in)	N/A
	X Walk 1 Slope (%)	0.8		X Walk 2 Slope (%)	N/A
	X Walk 1 X Slope (%)	2.0		X Walk 2 X Slope (%)	N/A
N/A	Ramp inside XWalk1?	N/A	N/A	Ramp inside XWalk2?	N/A

**Remove & Replace Entire Ramp.**
