## **Access Compliance Report Public Rights-of-Way** (Curb Ramps)

Intersection ID: 12089 Main Street: E 12TH ST **Cross Street: N DAVIDSON ST** Location: ADA ID: 280F289AC209 Ramp Type: PerpDiag Initial Pass/Fail: Fail **Overall Compliance: No Severity Score:** 37.5

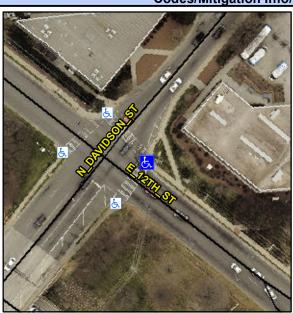
Not Found, R304.2.2, R304.5.3

| Comp | liance Description | Data | Comp | liance | Description | Data |
|---|---|---|---|---|---|---|
| N/A | Ramp Length (in) | 59.0 | No | Ramp | Slope (%) | 11.5 |
| Yes | Ramp Width (in) | 60.0 | No | Ramp | XSlope (%) | 9.4 |

**Remove & Replace Curb Ramp With** Two New Directional Ramps or Equivalent.
