Access Compliance Report Public Rights-of-Way (Curb Ramps)

Intersection ID: 15094Main Street: ALBEMARLE_RDCross Street: REDDMAN_RDLocation: NWADA ID: 281EDCE5C5FARamp Type: PerpInitial Pass/Fail: FailOverall Compliance: NoSeverity Score: 21.25

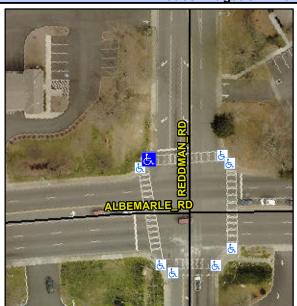
Comp	liance Description	Data	Comp	liance De	scription	Data
N/A	Ramp Length (in)	60.0	No	Ramp Slope (%)		9.6
No	Ramp Width (in)	42.0	Yes	Ramp XSlope (%)		1.7
N/A	Flare Type LT	N/A	N/A	Flare Type RT		N/A
N/A	Flare Slope LT (%)	N/A	N/A	Flare Slope RT (%)		N/A
N/A	Flare Traversable LT?	N/A	N/A	Flare Traversable RT?		N/A
N/A	Landing Length (in)	N/A	N/A	DWS Provided?		N/A
N/A	Landing Width (in)	N/A	N/A	DWS Contrast?		N/A
N/A	Landing Slope (%)	N/A	N/A	DWS Length (in)		N/A
N/A	Landing X Slope (%)	N/A	N/A	DWS Full Width?		N/A
N/A	Landing Curb? (Y/N)	N/A	N/A	DWS Offs	set (in)	N/A
N/A	Shared Landing?	N/A				
N/A	Gutter Ponding?	N/A	N/A	Gutter Slope (%)		N/A
N/A	Gutter Lip Ht (in)	N/A	N/A	Gutter X Slope (%)		N/A
N/A	Painted X Walk1?	Yes	N/A	Painted X	(Walk2?	N/A
	X Walk 1 Direction	To E		X Walk 2	Direction	N/A
N/A	X Walk 1 Width (in)	110.0	N/A	X Walk 2	Width (in)	N/A
	X Walk 1 Slope (%)	1.2		X Walk 2	Slope (%)	N/A
	X Walk 1 X Slope (%)	0.4		X Walk 2	X Slope (%)	N/A

N/A	Ramp inside XWalk1?	Yes	N/A	Ramp ins	ide XWalk2?	N/A
	Road Slope (%)	N/A	N/A	Clear Spa	ace?	N/A
	Road X Slope (%)	N/A	N/A	Clear Spa	ace to XWalk (in)	N/A
N/A	Any Obstructions?	N/A	N/A	Storm Gr	ate/Utility Hazard?	N/A
	Obstruction Type			Storm Gr	ate/Utility Type	
		N/A				N/A
			Yes	Surface (Condition? (G/P)	Good

Possible Solutions:				
Remove & Replace Entire Ramp.				
	N			
	N			
	1			
	1			
	1			
Surveyor Notes:	1			
N/A	1			
	1			
	1			
	1			
PROW/ADA:	1			
Not Found, R304.5.1, R304.2.2	N			
	1			
	1			
	N			
	r
