Access Compliance Report

Public Rights-of-Way

(Curb Ramps)

Intersection ID: N/A	Main Street: MELROSE_COTTAGE_DR	Cross Street: MARGARET_WALLACE_RD	Location: N
ADA ID: 282460BE3848	Ramp Type: PerpDiag	Initial Pass/Fail: Fail	Overall Compliance: No
Codes/Mitigation Info/Possible Solution		Field Measurements/Component Compliance	
Severity Score: 21.25

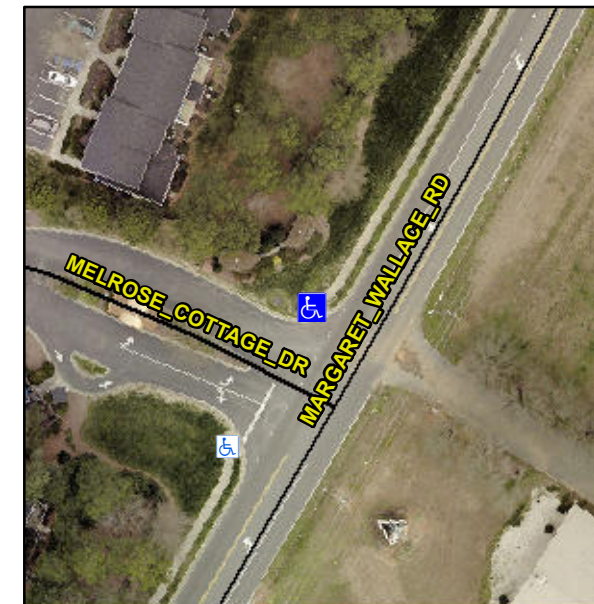
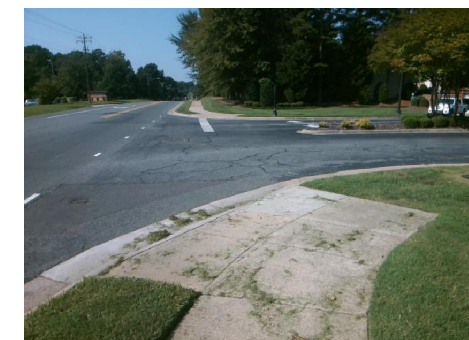
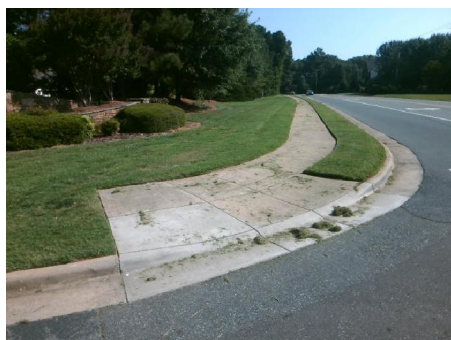
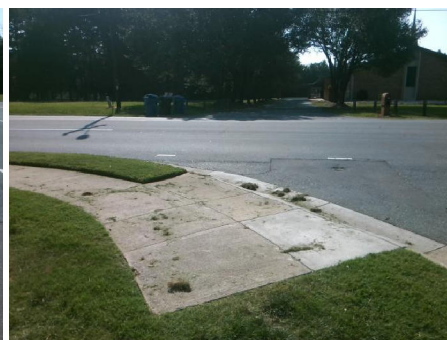
Not Found, R304.5.1, R304.2.2

Compliance	Description	Data	Compliance	Description	Data
N/A	Ramp Length (in)	45.0	No	Ramp Slope (%)	8.7
No	Ramp Width (in)	40.0	Yes	Ramp XSlope (%)	0.1
N/A	Flare Type LT	N/A	N/A	Flare Type RT	N/A
N/A	Flare Slope LT (%)	N/A	N/A	Flare Slope RT (%)	N/A
N/A	Flare Traversable LT?	N/A	N/A	Flare Traversable RT?	N/A
N/A	Landing Length (in)	N/A	N/A	DWS Provided?	N/A
N/A	Landing Width (in)	N/A	N/A	DWS Contrast?	N/A
N/A	Landing Slope (%)	N/A	N/A	DWS Length (in)	N/A
N/A	Landing X Slope (%)	N/A	N/A	DWS Full Width?	N/A
N/A	Landing Curb? (Y/N)	N/A	N/A	DWS Offset (in)	N/A
N/A	Shared Landing?	N/A			
N/A	Gutter Ponding?	N/A	N/A	Gutter Slope (%)	N/A
N/A	Gutter Lip Ht (in)	N/A	N/A	Gutter X Slope (%)	N/A
N/A	Painted X Walk1?	No	N/A	Painted X Walk2?	No
	X Walk 1 Direction	To SW		X Walk 2 Direction	To SE
N/A	X Walk 1 Width (in)	N/A	N/A	X Walk 2 Width (in)	N/A
	X Walk 1 Slope (%)	0.2		X Walk 2 Slope (%)	4.9
	X Walk 1 X Slope (%)	3.2		X Walk 2 X Slope (%)	3.5

N/A	Ramp inside XWalk1?	N/A	N/A	Ramp inside XWalk2?	N/A
	Road Slope (%)	4.0	N/A	Clear Space?	N/A
	Road X Slope (%)	2.2	N/A	Clear Space to XWalk (in)	N/A
N/A	Any Obstructions?	N/A	N/A	Storm Grate/Utility Hazard?	N/A
	Obstruction Type			Storm Grate/Utility Type	
		N/A			N/A
			Yes	Surface Condition? (G/P)	Good

Remove & Replace Curb Ramp With Two New Directional Ramps or Equivalent.
