Access Compliance Report

Public Rights-of-Way

(Curb Ramps)

Intersection ID: 31215	Main Street: OLDEHURST_PL	Cross Street: WRAYHILL_DR	Location: SE
ADA ID: 282CA0CF165C	Ramp Type: PerpDiag	Initial Pass/Fail: Fail	Overall Compliance: No
Severity Score: 33.75			
Codes/Mitigation Info/Possible Solution		Field Measurements/Component Compliance

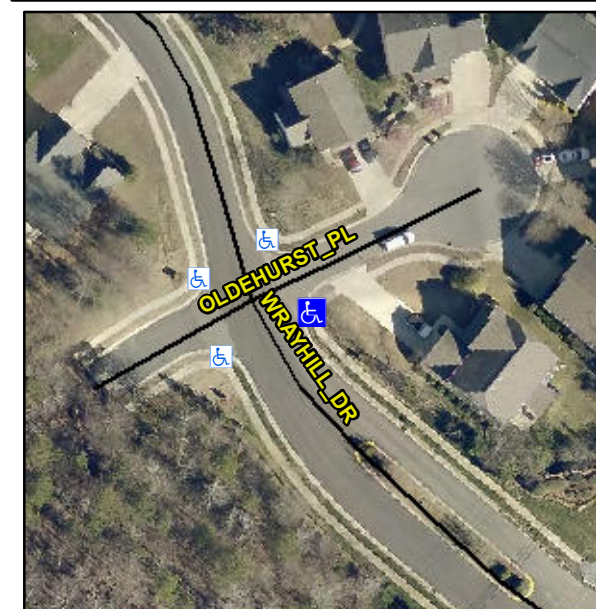
Not Found, R304.5.1, R304.2.2, R304.5.3

Compliance	Description	Data	Compliance	Description	Data
N/A	Ramp Length (in)	49.0	No	Ramp Slope (%)	8.8
No	Ramp Width (in)	40.5	No	Ramp XSlope (%)	6.1
N/A	Flare Type LT	N/A	N/A	Flare Type RT	N/A
N/A	Flare Slope LT (%)	N/A	N/A	Flare Slope RT (%)	N/A
N/A	Flare Traversable LT?	N/A	N/A	Flare Traversable RT?	N/A
N/A	Landing Length (in)	N/A	N/A	DWS Provided?	N/A
N/A	Landing Width (in)	N/A	N/A	DWS Contrast?	N/A
N/A	Landing Slope (%)	N/A	N/A	DWS Length (in)	N/A
N/A	Landing X Slope (%)	N/A	N/A	DWS Full Width?	N/A
N/A	Landing Curb? (Y/N)	N/A	N/A	DWS Offset (in)	N/A
N/A	Shared Landing?	N/A			
N/A	Gutter Ponding?	N/A	N/A	Gutter Slope (%)	N/A
N/A	Gutter Lip Ht (in)	N/A	N/A	Gutter X Slope (%)	N/A
N/A	Painted X Walk1?	No	N/A	Painted X Walk2?	No
	X Walk 1 Direction	To N		X Walk 2 Direction	To W
N/A	X Walk 1 Width (in)	N/A	N/A	X Walk 2 Width (in)	N/A
	X Walk 1 Slope (%)	1.5		X Walk 2 Slope (%)	1.2
	X Walk 1 X Slope (%)	0.6		X Walk 2 X Slope (%)	0.4

N/A	Ramp inside XWalk1?	N/A	N/A	Ramp inside XWalk2?	N/A
	Road Slope (%)	1.7	N/A	Clear Space?	N/A
	Road X Slope (%)	0.5	N/A	Clear Space to XWalk (in)	N/A
N/A	Any Obstructions?	N/A	N/A	Storm Grate/Utility Hazard?	N/A
	Obstruction Type			Storm Grate/Utility Type	
		N/A			N/A
		Yes		Surface Condition? (G/P)	Good

Possible Solutions:

Remove & Replace Curb Ramp With Two New Directional Ramps or Equivalent.
