## **Access Compliance Report Public Rights-of-Way** (Curb Ramps)

Intersection ID: 10034402 Main Street: PIEDMONT\_PARK\_DR Cross Street: POTOMAC\_RIVER\_PY Location: ADA ID: 2830D73AB2D2 Ramp Type: Directional1 Initial Pass/Fail: Fail **Overall Compliance: No** Severity Score: 26.25

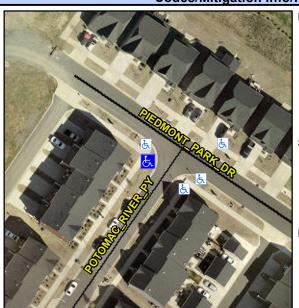
Field Measurements/Component Compliance							
Compl	iance Description	Data	Comp	liance Description	Data		
N/A	Ramp Length (in)	84.0	N/A	Grade Break?	N/A		
Yes	Ramp Width (in)	71.0	N/A	Grade Break Slope (%)	0.0		
No	Ramp Slope (%)	13.8	N/A	Grade Break XSlope (%)	0.0		
No	Ramp XSlope (%)	2.4					
N/A	Flare Type LT	N/A	N/A	Flare Type RT	N/A		
N/A	Flare Slope LT (%)	N/A	N/A	Flare Slope RT (%)	0.0		
N/A	Flare Traversable LT?	N/A	N/A	Flare Traversable RT?	N/A		
N/A	Landing Length (in)	0.0	N/A	DWS Provided?	N/A		
N/A	Landing Width (in)	0.0	N/A	DWS Contrast?	N/A		
N/A	Landing Slope (%)	0.0	N/A	DWS Length (in)	N/A		
N/A	Landing X Slope (%)	0.0	N/A	DWS Full Width?	N/A		
N/A	Landing Curb? (Y/N)	N/A	N/A	DWS Offset LT (in)	N/A		
N/A	Shared Landing?	N/A	N/A	DWS Offset RT (in)	N/A		
N/A	Gutter Ponding?	0.0	N/A	Gutter Slope (%)	N/A		
N/A	Gutter Lip Ht (in)	0.0	N/A	Gutter X Slope (%)	N/A		
N/A	Painted X Walk1?	No		Road Slope (%)	1.5

Possible Solutions: Remove & Replace Entire Ramp. Surveyor Notes: N/A PROW/ADA: R304.2.2, R304.5.3
