Access Compliance Report

Public Rights-of-Way (Curb Ramps)

Intersection ID: 11803	Main Street: MECKLENBURG_AV	Cross Street: DANIEL_ST	Location: NW
ADA ID: 2847D6A1D591	Ramp Type: Directional1	Initial Pass/Fail: Fail	Overall Compliance: No
		Severity Score: 1.25

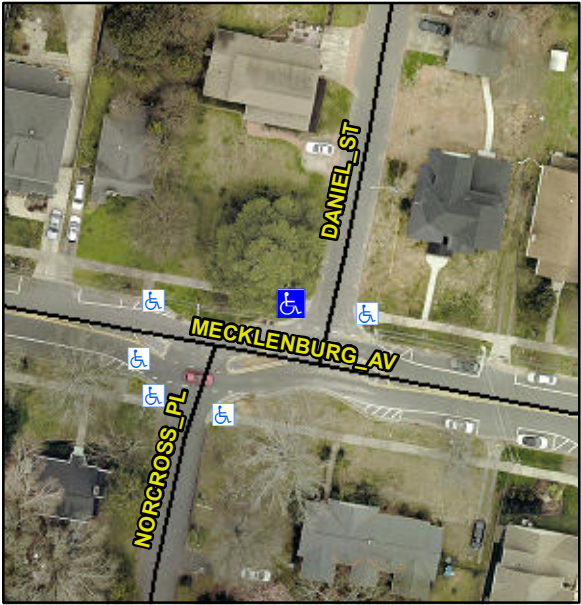
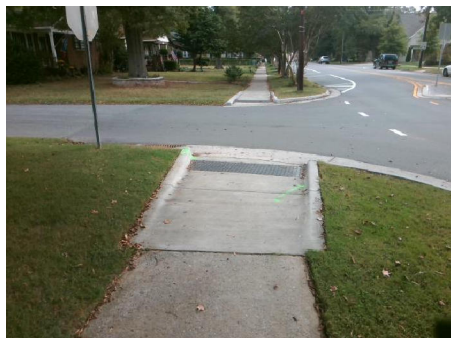
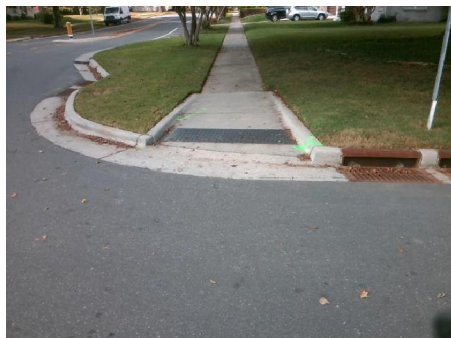
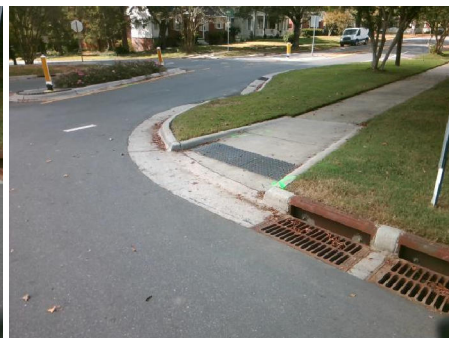
Compliance	Description	Data	Compliance	Description	Data
N/A	Ramp Length (in)	121.0	N/A	Grade Break?	N/A
Yes	Ramp Width (in)	65.0	N/A	Grade Break Slope (%)	0.0
Yes	Ramp Slope (%)	5.1	N/A	Grade Break XSlope (%)	0.0
No	Ramp XSlope (%)	2.5			
N/A	Flare Type LT	N/A	N/A	Flare Type RT	N/A
N/A	Flare Slope LT (%)	N/A	N/A	Flare Slope RT (%)	0.0
N/A	Flare Traversable LT?	N/A	N/A	Flare Traversable RT?	N/A
N/A	Landing Length (in)	0.0	N/A	DWS Provided?	N/A
N/A	Landing Width (in)	0.0	N/A	DWS Contrast?	N/A
N/A	Landing Slope (%)	0.0	N/A	DWS Length (in)	N/A
N/A	Landing X Slope (%)	0.0	N/A	DWS Full Width?	N/A
N/A	Landing Curb? (Y/N)	N/A	N/A	DWS Offset LT (in)	N/A
N/A	Shared Landing?	N/A	N/A	DWS Offset RT (in)	N/A
N/A	Gutter Ponding?	0.0	N/A	Gutter Slope (%)	N/A
N/A	Gutter Lip Ht (in)	0.0	N/A	Gutter X Slope (%)	N/A
N/A	Painted X Walk1?	No		Road Slope (%)	0.9
	X Walk 1 Direction	To E		Road X Slope (%)	1.5
	X Walk 1 Width (in)	N/A		Clear Space?	N/A

X Walk 1 Slope (%)	0.9	N/A	Clear Space to XWalk (in)	N/A
	X Walk 1 X Slope (%)	1.5	N/A	Storm Grate/Utility Hazard?	N/A
N/A	Ramp inside XWalk1?	N/A		Storm Grate/Utility Type	
N/A	Any Obstructions?	N/A			N/A
	Obstruction Type		Yes	Surface Condition? (G/P)	Good
			N/A	Curb Slope (%)	10.1

Possible Solutions:			
		Remove & Replace Entire Ramp.			
<p>Surveyor Notes:</p> <p>N/A</p>					
<p>PROW/ADA:</p> <p>R304.5.3</p>					
Street 1 Name	DANIEL ST				
Stop Condition-Street 1	StopSign				
Street 2 Name	N/A				
Stop Condition-Street 2	N/A				
<p>Total Cost:</p> <p>\$ 1600.00</p>
