## Access Compliance Report Public Rights-of-Way (Curb Ramps)

Intersection ID: 50636Main Street:BLUE\_GROVE\_RDCross Street:RED\_WATER\_RDLocation:NEADA ID: 285FFFE00E5ARamp Type:PerpInitial Pass/Fail:FailOverall Compliance:NoSeverity Score:10

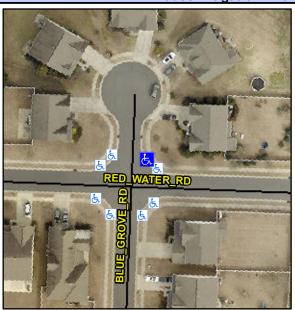
Street 1 Name	BLUE GROVE RD
Stop Condition-Street 2	StopSign
Street 2 Name	N/A
Stop Condition-Street 1	N/A

Field Measurements/Component Compliance								
Compl	iance Description	Data	Comp	oliance	Description	Data		
N/A	Ramp Length (in)	46.0	Yes	Ramp	Slope (%)	8.2		
No	Ramp Width (in)	45.5	No	Ramp	XSlope (%)	2.6		
N/A	Flare Type LT	N/A	N/A	N/A Flare Type RT		N/A		
N/A	Flare Slope LT (%)	N/A	N/A	N/A Flare Slope RT (%)		N/A		
N/A	Flare Traversable LT?	N/A	N/A	N/A Flare Traversable RT?		N/A		
N/A	Landing Length (in)	N/A	N/A	N/A DWS Provided?		N/A		
N/A	Landing Width (in)	N/A	N/A	N/A DWS Contrast?		N/A		
N/A	Landing Slope (%)	N/A	N/A	DWS	Length (in)	N/A		
N/A	Landing X Slope (%)	N/A	N/A	DWS	Full Width?	N/A		
N/A	Landing Curb? (Y/N)	N/A	N/A	DWS	Offset (in)	N/A		
N/A	Shared Landing?	N/A						
N/A	Gutter Ponding?	N/A	N/A	Gutte	Slope (%)	N/A		
N/A	Gutter Lip Ht (in)	N/A	N/A	Gutte	X Slope (%)	N/A		
N/A	Painted X Walk1?	No	N/A	Painte	ed X Walk2?	N/A		
	X Walk 1 Direction	To NW		X Wal	k 2 Direction	N/A		
N/A	X Walk 1 Width (in)	N/A	N/A	X Wal	k 2 Width (in)	N/A

X Walk 1 Slope (%)	1.6		X Wal	k 2 Slope (%)	N/A		
	X Walk 1 X Slope (%)	3.0		X Wal	k 2 X Slope (%)	N/A		
N/A	Ramp inside XWalk1?	N/A	N/A	Ramp	inside XWalk2?	N/A		
	Road Slope (%)	N/A	N/A	Clear	Space?	N/A		
	Road X Slope (%)	N/A	N/A	Clear	Space to XWalk (in)	N/A		
N/A	Any Obstructions?	N/A	N/A	Storm	Grate/Utility Hazard?	N/A		
	Obstruction Type			Storm	Grate/Utility Type			
		N/A				N/A		
			Yes	Surfac	ce Condition? (G/P)	Good

Possible Solutions:	Co
Remove & Replace Entire Ramp.	
	No
	N/
	N/
	N/
	N/
Surveyor Notes:	N/
N/A	N/
	N/
	N/
	N/
PROW/ADA:	N/
Not Found, R304.5.1, R304.5.3	N/
	N/
	N/
	N/

1850.00
