# Access Compliance Report

## Public Rights-of-Way

### (Curb Ramps)

| Intersection ID: 45505 | Main Street: GINHOUSE_LN | Cross Street: MEADOW_BOTTOM_RD | Location: SE |

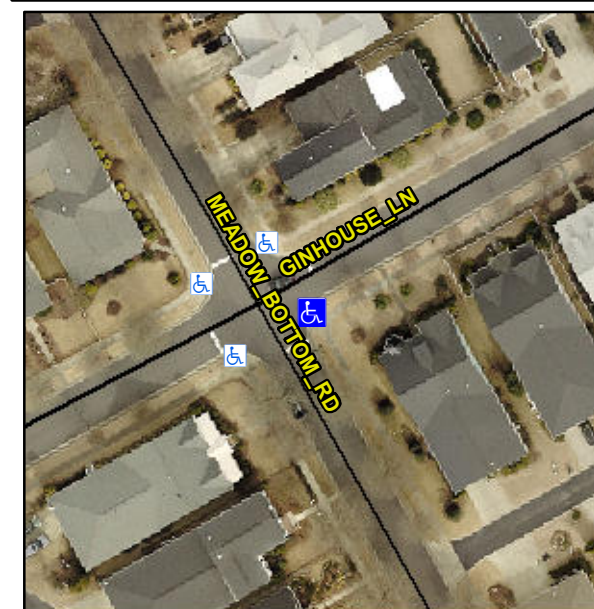
| ADA ID: 2873C18E8F56 | Ramp Type: PerpDiag | Initial Pass/Fail: Fail | Overall Compliance: No |
| Severity Score: 21.25 | | | |

**Not Found, R304.5.1, R304.2.2**

| Compliance | Description | Data | Compliance | Description | Data |
|---|---|---|---|---|---|
| N/A | Ramp Length (in) | 71.0 | No | Ramp Slope (%) | 8.7 |
| No | Ramp Width (in) | 36.0 | Yes | Ramp XSlope (%) | 1.3 |

**Remove & Replace Curb Ramp With Two New Directional Ramps or Equivalent.**
