# Access Compliance Report

## Public Rights-of-Way

### (Curb Ramps)

Intersection ID: 11981	Main Street: W_6TH_ST	Cross Street: N_CHURCH_ST	Location: S
ADA ID: 2876B78A4207	Ramp Type: PerpDiag	Initial Pass/Fail: Fail	Overall Compliance: No
Codes/Mitigation Info/Possible Solution		Field Measurements/Component Compliance

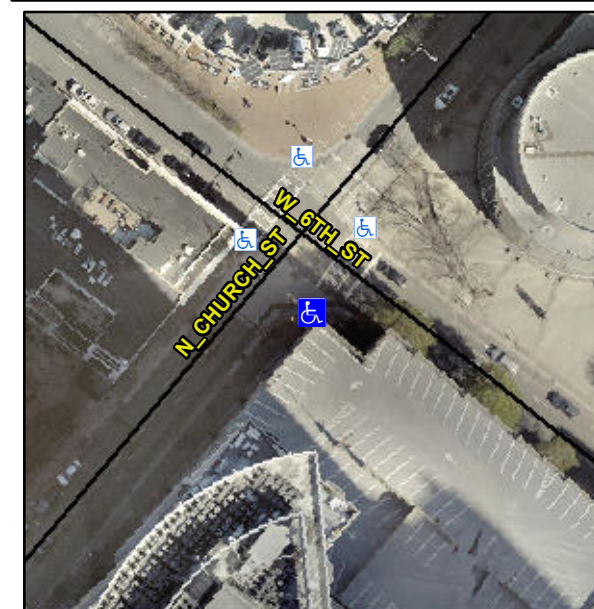
**Not Found, R304.2.2, R304.5.3**

Compliance	Description	Data	Compliance	Description	Data
N/A	Ramp Length (in)	78.0	No	Ramp Slope (%)	11.4
Yes	Ramp Width (in)	115.0	No	Ramp XSlope (%)	2.9
N/A	Flare Type LT	N/A	N/A	Flare Type RT	N/A
N/A	Flare Slope LT (%)	N/A	N/A	Flare Slope RT (%)	N/A
N/A	Flare Traversable LT?	N/A	N/A	Flare Traversable RT?	N/A
N/A	Landing Length (in)	N/A	N/A	DWS Provided?	N/A
N/A	Landing Width (in)	N/A	N/A	DWS Contrast?	N/A
N/A	Landing Slope (%)	N/A	N/A	DWS Length (in)	N/A
N/A	Landing X Slope (%)	N/A	N/A	DWS Full Width?	N/A
N/A	Landing Curb? (Y/N)	N/A	N/A	DWS Offset (in)	N/A
N/A	Shared Landing?	N/A			
N/A	Gutter Ponding?	N/A	N/A	Gutter Slope (%)	N/A
N/A	Gutter Lip Ht (in)	N/A	N/A	Gutter X Slope (%)	N/A
N/A	Painted X Walk1?	Yes	N/A	Painted X Walk2?	No
	X Walk 1 Direction	To NE		X Walk 2 Direction	To NW
N/A	X Walk 1 Width (in)	105.0	N/A	X Walk 2 Width (in)	N/A
	X Walk 1 Slope (%)	3.8		X Walk 2 Slope (%)	1.1
	X Walk 1 X Slope (%)	4.0		X Walk 2 X Slope (%)	2.0

N/A	Ramp inside XWalk1?	Yes	N/A	Ramp inside XWalk2?	N/A
	Road Slope (%)	0.9	N/A	Clear Space?	N/A
	Road X Slope (%)	1.3	N/A	Clear Space to XWalk (in)	N/A
N/A	Any Obstructions?	N/A	N/A	Storm Grate/Utility Hazard?	N/A
	Obstruction Type			Storm Grate/Utility Type	
		N/A			N/A
		Yes		Surface Condition? (G/P)	Good

**Remove & Replace Curb Ramp With Two New Directional Ramps or Equivalent.**

Total Cost: \$ 3200.00
