Access Compliance Report Public Rights-of-Way (Curb Ramps)

Intersection ID: 10022634Main Street: CARMEL_RDCross Street: N/ALocation:NWADA ID: 2879BF36A28BRamp Type: PerpDiagInitial Pass/Fail: FailOverall Compliance: NoSeverity Score: 8.75

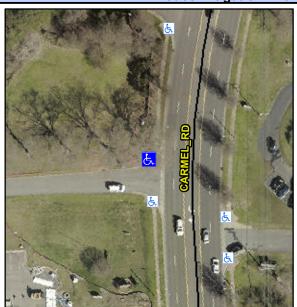
Field Measurements/Component Compliance					
Compliance Description		Data	Com	oliance Description	Data
N/	A Ramp Length (in)	58.0	Yes	Ramp Slope (%)	6.1
No	Ramp Width (in)	43.5	Yes	Ramp XSlope (%)	1.3
N/	A Flare Type LT	N/A	N/A	Flare Type RT	N/A
N/	A Flare Slope LT (%)	N/A	N/A	Flare Slope RT (%)	N/A
N/	A Flare Traversable LT?	N/A	N/A	Flare Traversable RT?	N/A
N/	A Landing Length (in)	N/A	N/A	DWS Provided?	N/A
N/	A Landing Width (in)	N/A	N/A	DWS Contrast?	N/A
N/	A Landing Slope (%)	N/A	N/A	DWS Length (in)	N/A
N/	A Landing X Slope (%)	N/A	N/A	DWS Full Width?	N/A
N/	A Landing Curb? (Y/N)	N/A	N/A	DWS Offset (in)	N/A
N/	A Shared Landing?	N/A			
N/	A Gutter Ponding?	N/A	N/A	Gutter Slope (%)	N/A
N/	A Gutter Lip Ht (in)	N/A	N/A	Gutter X Slope (%)	N/A
N/	A Painted X Walk1?	No	N/A	Painted X Walk2?	No
	X Walk 1 Direction	To SW		X Walk 2 Direction	To SE
N/	X Walk 1 Width (in)	N/A	N/A	X Walk 2 Width (in)	N/A
	X Walk 1 Slope (%)	1.2		X Walk 2 Slope (%)	1.3

X Walk 1 X Slope (%)	3.8		X Walk 2 X Slope (%)	0.4
N/	A Ramp inside XWalk1?	N/A	N/A	Ramp inside XWalk2?	N/A
	Road Slope (%)	2.5	N/A	Clear Space?	N/A
	Road X Slope (%)	2.7	N/A	Clear Space to XWalk (in)	N/A
N/	Any Obstructions?	N/A	N/A	Storm Grate/Utility Hazard?	N/A
	Obstruction Type			Storm Grate/Utility Type	
		N/A			N/A
			Yes	Surface Condition? (G/P)	Good
A THE

Remove & Replace Curb Ramp With Two New Directional Ramps or Equivalent.

Not Found, R304.5.1

Total Cost: \$ 3200.00
