Access Compliance Report

Public Rights-of-Way

(Curb Ramps)

Intersection ID: 31225	Main Street: CLACKWYCK_LN	Cross Street: GRANTHAM_LN	Location: E
ADA ID: 287E59C503E5	Ramp Type: Perp	Initial Pass/Fail: Fail	Overall Compliance: No
		Severity Score: 50

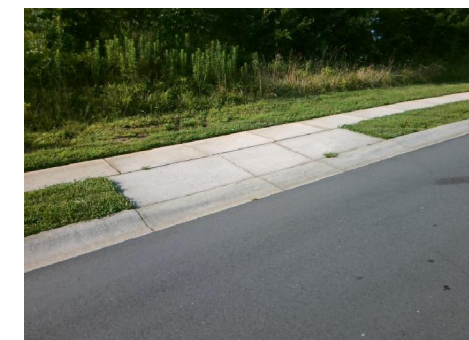
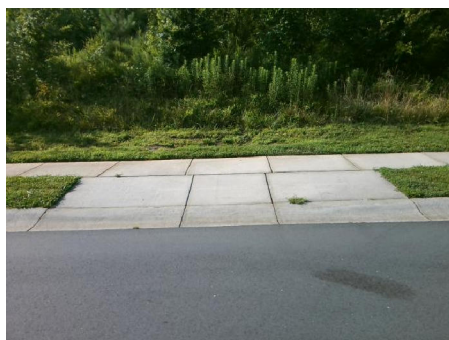
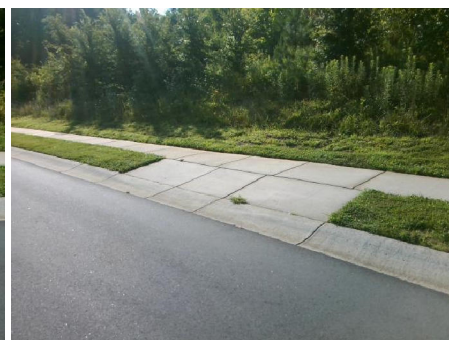
Not Found, R304.2.2, R304.5.3

Compliance	Description	Data	Compliance	Description	Data
N/A	Ramp Length (in)	45.0	No	Ramp Slope (%)	13.9
Yes	Ramp Width (in)	48.0	No	Ramp XSlope (%)	10.3
N/A	Flare Type LT	N/A	N/A	Flare Type RT	N/A
N/A	Flare Slope LT (%)	N/A	N/A	Flare Slope RT (%)	N/A
N/A	Flare Traversable LT?	N/A	N/A	Flare Traversable RT?	N/A
N/A	Landing Length (in)	N/A	N/A	DWS Provided?	N/A
N/A	Landing Width (in)	N/A	N/A	DWS Contrast?	N/A
N/A	Landing Slope (%)	N/A	N/A	DWS Length (in)	N/A
N/A	Landing X Slope (%)	N/A	N/A	DWS Full Width?	N/A
N/A	Landing Curb? (Y/N)	N/A	N/A	DWS Offset (in)	N/A
N/A	Shared Landing?	N/A			
N/A	Gutter Ponding?	N/A	N/A	Gutter Slope (%)	N/A
N/A	Gutter Lip Ht (in)	N/A	N/A	Gutter X Slope (%)	N/A
N/A	Painted X Walk1?	No	N/A	Painted X Walk2?	N/A
	X Walk 1 Direction	To NW		X Walk 2 Direction	N/A
N/A	X Walk 1 Width (in)	N/A	N/A	X Walk 2 Width (in)	N/A
	X Walk 1 Slope (%)	4.7		X Walk 2 Slope (%)	N/A
	X Walk 1 X Slope (%)	10.0		X Walk 2 X Slope (%)	N/A

N/A	Ramp inside XWalk1?	N/A	N/A	Ramp inside XWalk2?	N/A
	Road Slope (%)	N/A	N/A	Clear Space?	N/A
	Road X Slope (%)	N/A	N/A	Clear Space to XWalk (in)	N/A
N/A	Any Obstructions?	N/A	N/A	Storm Grate/Utility Hazard?	N/A
	Obstruction Type			Storm Grate/Utility Type	
		N/A			N/A
			Yes	Surface Condition? (G/P)	Good

Remove & Replace Entire Ramp.
