Access Compliance Report

Public Rights-of-Way

(Curb Ramps)

Intersection ID: 5837	Main Street: BLACK WALNUT LN	Cross Street: PEPPERBUSH CT	Location: W
ADA ID: 2881F027AF40	Ramp Type: Perp	Initial Pass/Fail: Fail	Overall Compliance: No
Severity Score: 10			
Codes/Mitigation Info/Possible Solution		Field Measurements/Component Compliance

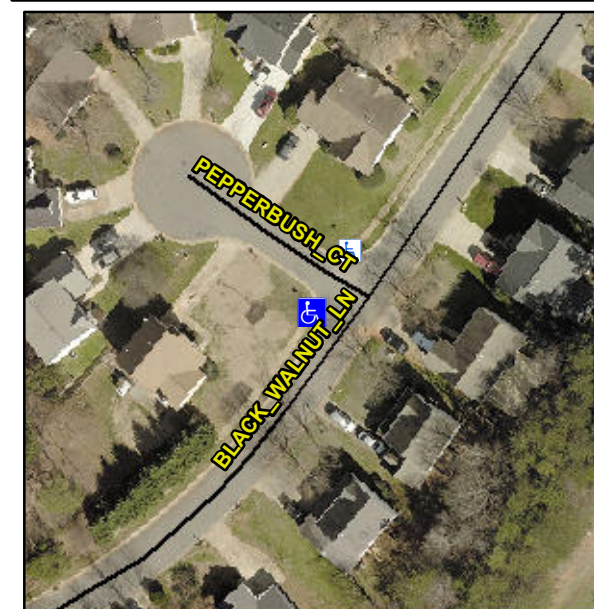
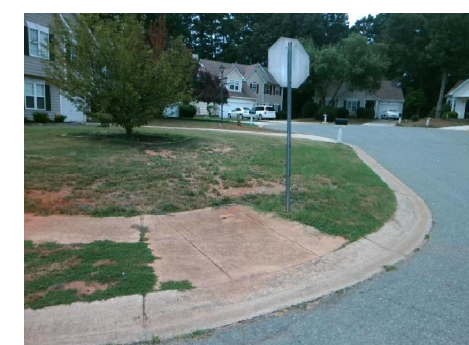
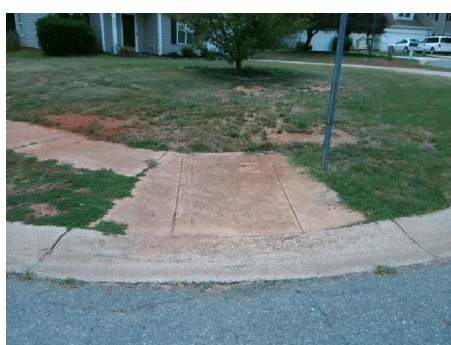
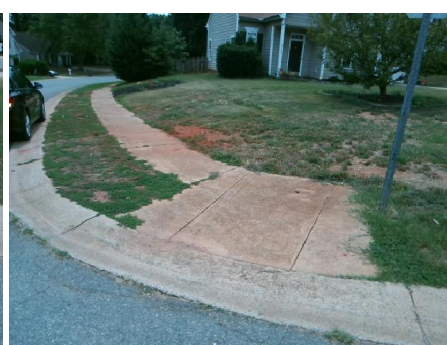
Not Found, R304.5.1, R304.5.3

Compliance	Description	Data	Compliance	Description	Data
N/A	Ramp Length (in)	98.0	Yes	Ramp Slope (%)	7.0
No	Ramp Width (in)	47.5	No	Ramp XSlope (%)	2.8
N/A	Flare Type LT	N/A	N/A	Flare Type RT	N/A
N/A	Flare Slope LT (%)	N/A	N/A	Flare Slope RT (%)	N/A
N/A	Flare Traversable LT?	N/A	N/A	Flare Traversable RT?	N/A
N/A	Landing Length (in)	N/A	N/A	DWS Provided?	N/A
N/A	Landing Width (in)	N/A	N/A	DWS Contrast?	N/A
N/A	Landing Slope (%)	N/A	N/A	DWS Length (in)	N/A
N/A	Landing X Slope (%)	N/A	N/A	DWS Full Width?	N/A
N/A	Landing Curb? (Y/N)	N/A	N/A	DWS Offset (in)	N/A
N/A	Shared Landing?	N/A			
N/A	Gutter Ponding?	N/A	N/A	Gutter Slope (%)	N/A
N/A	Gutter Lip Ht (in)	0.5	N/A	Gutter X Slope (%)	N/A
N/A	Painted X Walk1?	No	N/A	Painted X Walk2?	N/A
	X Walk 1 Direction	To NE		X Walk 2 Direction	N/A
N/A	X Walk 1 Width (in)	N/A	N/A	X Walk 2 Width (in)	N/A
	X Walk 1 Slope (%)	5.1		X Walk 2 Slope (%)	N/A
	X Walk 1 X Slope (%)	1.1		X Walk 2 X Slope (%)	N/A

N/A	Ramp inside XWalk1?	N/A	N/A	Ramp inside XWalk2?	N/A
	Road Slope (%)	N/A	N/A	Clear Space?	N/A
	Road X Slope (%)	N/A	N/A	Clear Space to XWalk (in)	N/A
N/A	Any Obstructions?	N/A	N/A	Storm Grate/Utility Hazard?	N/A
	Obstruction Type			Storm Grate/Utility Type	
		N/A			N/A
			Yes	Surface Condition? (G/P)	Good

Remove & Replace Entire Ramp.

Total Cost: \$ 1850.00
