Access Compliance Report

Public Rights-of-Way

(Curb Ramps)

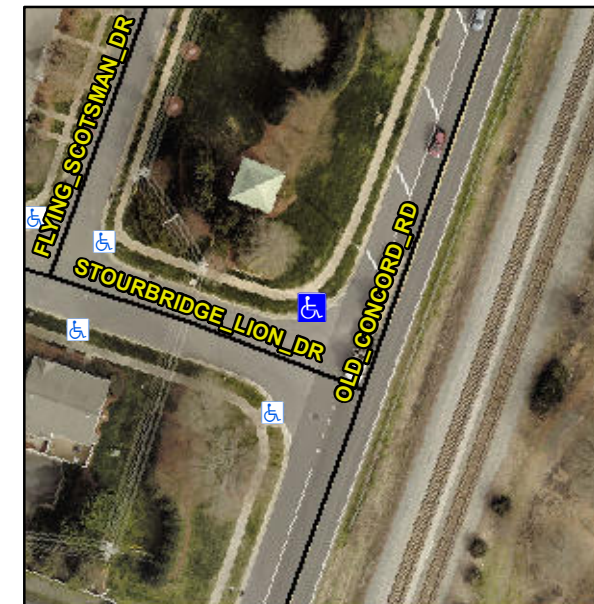
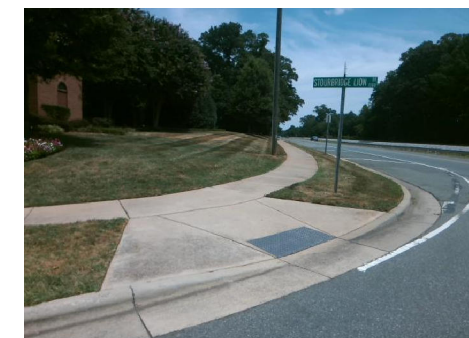
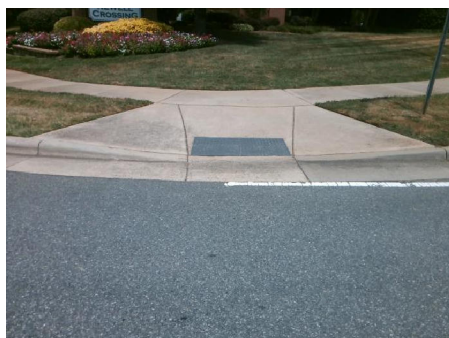
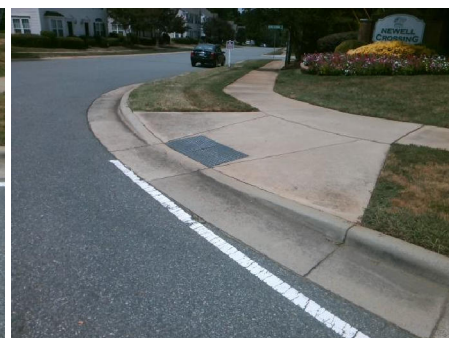
Intersection ID: 30329	Main Street: OLD_CONCORD_RD	Cross Street: STOURBRIDGE_LION_DR	Location:	N
ADA ID: 288CECCE0286	Ramp Type: Perp	Initial Pass/Fail: Fail	Overall Compliance: No	Severity Score: 1.25
Codes/Mitigation Info/Possible Solution		Field Measurements/Component Compliance

Compliance	Description	Data	Compliance	Description	Data
N/A	Ramp Length (in)	88.0	Yes	Ramp Slope (%)	7.0
Yes	Ramp Width (in)	50.5	No	Ramp XSlope (%)	3.3
N/A	Flare Type LT	N/A	N/A	Flare Type RT	N/A
N/A	Flare Slope LT (%)	N/A	N/A	Flare Slope RT (%)	N/A
N/A	Flare Traversable LT?	N/A	N/A	Flare Traversable RT?	N/A
N/A	Landing Length (in)	N/A	N/A	DWS Provided?	N/A
N/A	Landing Width (in)	N/A	N/A	DWS Contrast?	N/A
N/A	Landing Slope (%)	N/A	N/A	DWS Length (in)	N/A
N/A	Landing X Slope (%)	N/A	N/A	DWS Full Width?	N/A
N/A	Landing Curb? (Y/N)	N/A	N/A	DWS Offset (in)	N/A
N/A	Shared Landing?	N/A			
N/A	Gutter Ponding?	N/A	N/A	Gutter Slope (%)	N/A
N/A	Gutter Lip Ht (in)	N/A	N/A	Gutter X Slope (%)	N/A
N/A	Painted X Walk1?	No	N/A	Painted X Walk2?	N/A
	X Walk 1 Direction	To SW		X Walk 2 Direction	N/A
N/A	X Walk 1 Width (in)	N/A	N/A	X Walk 2 Width (in)	N/A
	X Walk 1 Slope (%)	0.6		X Walk 2 Slope (%)	N/A
	X Walk 1 X Slope (%)	2.0		X Walk 2 X Slope (%)	N/A

N/A	Ramp inside XWalk1?	N/A	N/A	Ramp inside XWalk2?	N/A
	Road Slope (%)	N/A	N/A	Clear Space?	N/A
	Road X Slope (%)	N/A	N/A	Clear Space to XWalk (in)	N/A
N/A	Any Obstructions?	N/A	N/A	Storm Grate/Utility Hazard?	N/A
	Obstruction Type			Storm Grate/Utility Type	
		N/A			N/A
			Yes	Surface Condition? (G/P)	Good

Remove & Replace Entire Ramp.

R304.5.3
