# Access Compliance Report

## Public Rights-of-Way

### (Curb Ramps)

| Intersection ID: N/A | Main Street: S TRYON ST | Cross Street: CAMDEN RD | Location: S |

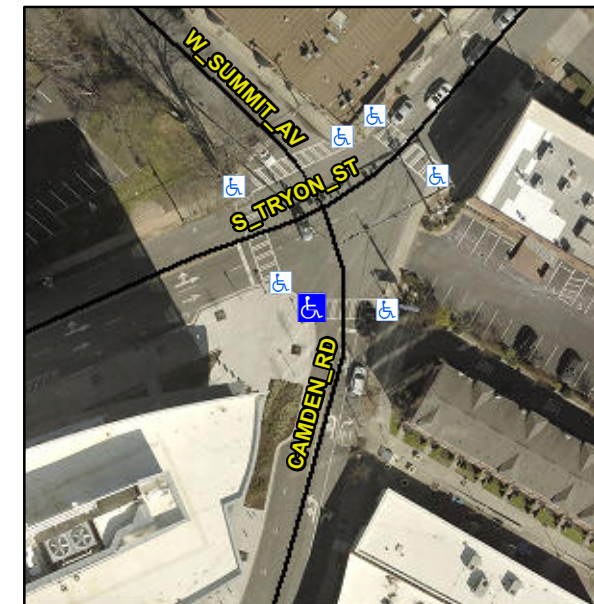
| Severity Score: 7.5 | | | |

**R305.2, R302.7.2**

| Compliance | Description | Data | Compliance | Description | Data |
|---|---|---|---|---|---|
| N/A | Landing Curb? (Y/N) | No | No | DWS Offset (in) | 6.5 |
| No | Gutter Lip Ht (in) | 0.5 | Yes | Gutter X Slope (%) | 0.4 |

**Remove & Replace Detectable Warning System. Grind Gutter Lip.**

Total Cost: \$ 1000.00

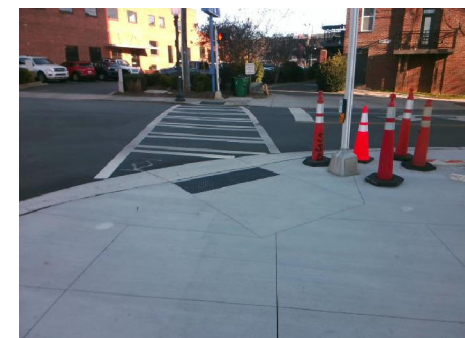
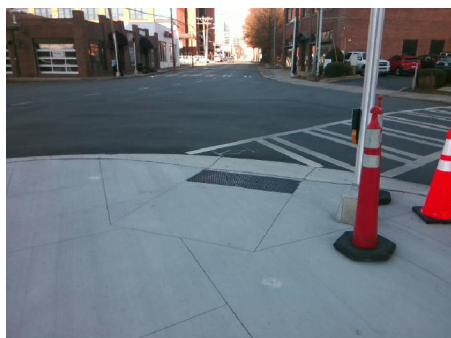
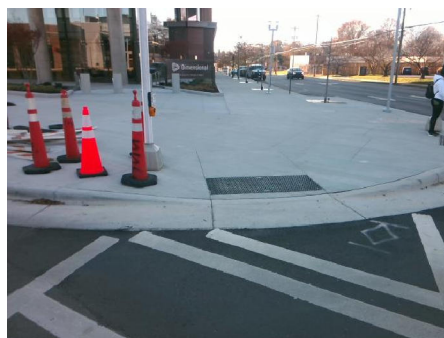
PROW/ADA:

Possible Solutions:
