## **Access Compliance Report Public Rights-of-Way** (Curb Ramps)

Intersection ID: 47611 Main Street: WYALONG DR Cross Street: MINTWORTH\_AV Location: NE ADA ID: 28C27E1CC838 Ramp Type: Perp Initial Pass/Fail: Fail **Overall Compliance: No Severity Score:** 25

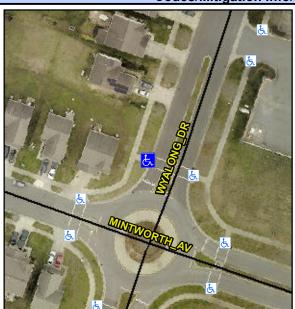
Field Measurements/Component Compliance								
Comp	liance Description	Data	Comp	liance	Description	Data		
N/A	Ramp Length (in)	67.0	No	Ramp	Slope (%)	12.0		
Yes	Ramp Width (in)	71.0	Yes	Ramp	XSlope (%)	0.5		
N/A	Flare Type LT	N/A	N/A	Flare	Type RT	N/A		
N/A	Flare Slope LT (%)	N/A	N/A	Flare	Slope RT (%)	N/A		
N/A	Flare Traversable LT?	N/A	N/A	Flare	Traversable RT?	N/A		
N/A	Landing Length (in)	N/A	N/A	DWS	Provided?	N/A		
N/A	Landing Width (in)	N/A	N/A	DWS	Contrast?	N/A		
N/A	Landing Slope (%)	N/A	N/A	DWS	Length (in)	N/A		
N/A	Landing X Slope (%)	N/A	N/A	DWS	Full Width?	N/A		
N/A	Landing Curb? (Y/N)	N/A	N/A	DWS	Offset (in)	N/A		
N/A	Shared Landing?	N/A						
N/A	Gutter Ponding?	N/A	N/A	Gutte	r Slope (%)	N/A		
N/A	Gutter Lip Ht (in)	N/A	N/A	Gutte	r X Slope (%)	N/A		
N/A	Painted X Walk1?	Yes	N/A	Paint	ed X Walk2?	N/A		
	X Walk 1 Direction	To SE		X Wa	lk 2 Direction	N/A		
N/A	X Walk 1 Width (in)	119.0	N/A	X Wa	lk 2 Width (in)	N/A

OSSIDIE SCIULIOII	
Possible Solutions:	Col
Remove & Replace Entire Ramp.	N/A
·	Yes
	N/A
	N/A
	N/A
	N/A
Surveyor Notes:	N/A
N/A	N/A
	N/A
	N/A
	N/A
PROW/ADA:	N/A
Not Found, R304.2.2	N/A
	N/A
	N/A
	N/A
