# Access Compliance Report

## Public Rights-of-Way

### (Curb Ramps)

| Intersection ID: 47454 | Main Street: WOOD_DUCK_CROSSING_DR | Cross Street: WINGED_TEAL_RD | Location: NW |

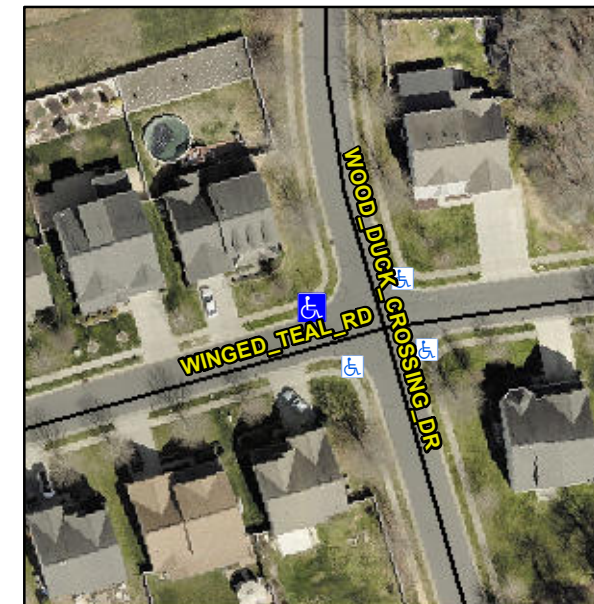
| ADA ID: 28C61293F1C7 | Ramp Type: PerpDiag | Initial Pass/Fail: Fail | Overall Compliance: No |

**Not Found, R304.5.1, R304.5.3**

| Compliance | Description | Data | Compliance | Description | Data |
|---|---|---|---|---|---|
| N/A | Ramp Length (in) | 45.5 | Yes | Ramp Slope (%) | 6.6 |
| No | Ramp Width (in) | 46.0 | No | Ramp XSlope (%) | 3.1 |

**Remove & Replace Curb Ramp With Two New Directional Ramps or Equivalent.**
