Access Compliance Report

Public Rights-of-Way

(Curb Ramps)

Intersection ID: 11674	Main Street: HEARN_PL	Cross Street: N_GRAHAM_ST	Location: W
ADA ID: 28CC57D9B0C8	Ramp Type: Directional1	Initial Pass/Fail: Fail	Overall Compliance: No
Severity Score: 12.5			
Codes/Mitigation Info/Possible Solution		Field Measurements/Component Compliance

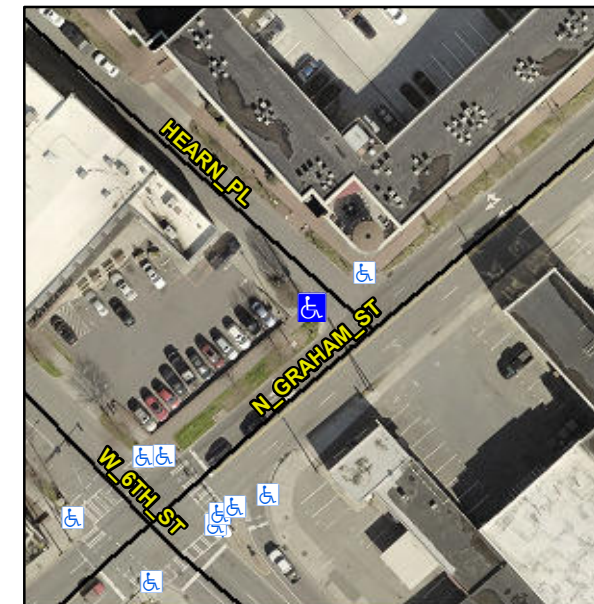
Compliance	Description	Data	Compliance	Description	Data
N/A	Ramp Length (in)	34.0	N/A	Grade Break?	N/A
Yes	Ramp Width (in)	48.0	N/A	Grade Break Slope (%)	0.0
No	Ramp Slope (%)	10.9	N/A	Grade Break XSlope (%)	0.0
Yes	Ramp XSlope (%)	1.5			
N/A	Flare Type LT	N/A	N/A	Flare Type RT	N/A
N/A	Flare Slope LT (%)	N/A	N/A	Flare Slope RT (%)	0.0
N/A	Flare Traversable LT?	N/A	N/A	Flare Traversable RT?	N/A
N/A	Landing Length (in)	0.0	N/A	DWS Provided?	N/A
N/A	Landing Width (in)	0.0	N/A	DWS Contrast?	N/A
N/A	Landing Slope (%)	0.0	N/A	DWS Length (in)	N/A
N/A	Landing X Slope (%)	0.0	N/A	DWS Full Width?	N/A
N/A	Landing Curb? (Y/N)	N/A	N/A	DWS Offset LT (in)	N/A
N/A	Shared Landing?	N/A	N/A	DWS Offset RT (in)	N/A
N/A	Gutter Ponding?	0.0	N/A	Gutter Slope (%)	N/A
N/A	Gutter Lip Ht (in)	0.0	N/A	Gutter X Slope (%)	N/A
N/A	Painted X Walk1?	No		Road Slope (%)	5.8
	X Walk 1 Direction	To NE		Road X Slope (%)	2.3
	X Walk 1 Width (in)	N/A		Clear Space?	N/A

X Walk 1 Slope (%)	5.8	N/A	Clear Space to XWalk (in)	N/A
	X Walk 1 X Slope (%)	2.3	N/A	Storm Grate/Utility Hazard?	N/A
N/A	Ramp inside XWalk1?	N/A		Storm Grate/Utility Type	
N/A	Any Obstructions?	N/A			N/A
	Obstruction Type		Yes	Surface Condition? (G/P)	Good
			N/A	Curb Slope (%)	3.2

Possible Solutions:

Remove & Replace Entire Ramp.

R304.2.2

\$ 1600.00
