# Access Compliance Report

## Public Rights-of-Way

### (Curb Ramps)

Intersection ID: 11256	Main Street: N_IRWIN_AV	Cross Street: W_5TH_ST	Location: S
ADA ID: 28CF15C49E23	Ramp Type: Perp	Initial Pass/Fail: Fail	Overall Compliance: No
			Severity Score: 13.75

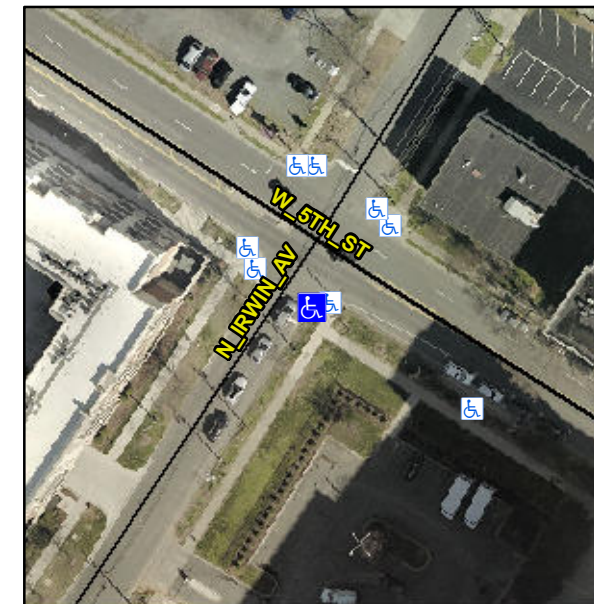
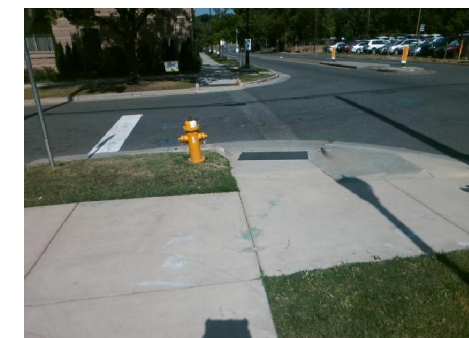
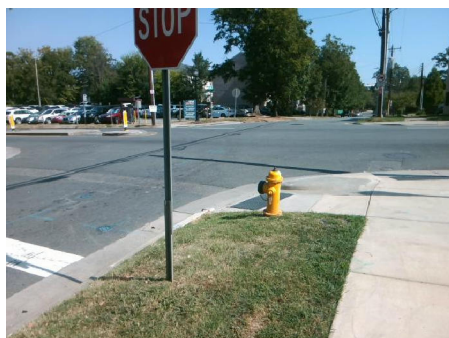
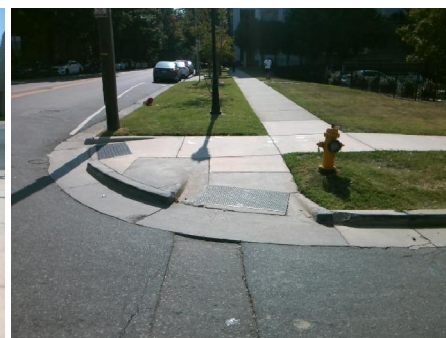
Compliance	Description	Data	Compliance	Description	Data
N/A	Ramp Length (in)	84.0	No	Ramp Slope (%)	9.2
Yes	Ramp Width (in)	66.0	No	Ramp XSlope (%)	2.6
N/A	Flare Type LT	N/A	N/A	Flare Type RT	N/A
N/A	Flare Slope LT (%)	N/A	N/A	Flare Slope RT (%)	N/A
N/A	Flare Traversable LT?	N/A	N/A	Flare Traversable RT?	N/A
N/A	Landing Length (in)	N/A	N/A	DWS Provided?	N/A
N/A	Landing Width (in)	N/A	N/A	DWS Contrast?	N/A
N/A	Landing Slope (%)	N/A	N/A	DWS Length (in)	N/A
N/A	Landing X Slope (%)	N/A	N/A	DWS Full Width?	N/A
N/A	Landing Curb? (Y/N)	N/A	N/A	DWS Offset (in)	N/A
N/A	Shared Landing?	N/A			
N/A	Gutter Ponding?	N/A	N/A	Gutter Slope (%)	N/A
N/A	Gutter Lip Ht (in)	N/A	N/A	Gutter X Slope (%)	N/A
N/A	Painted X Walk1?	No	N/A	Painted X Walk2?	N/A
	X Walk 1 Direction	To NW		X Walk 2 Direction	N/A
N/A	X Walk 1 Width (in)	N/A	N/A	X Walk 2 Width (in)	N/A
	X Walk 1 Slope (%)	1.4		X Walk 2 Slope (%)	N/A
	X Walk 1 X Slope (%)	2.2		X Walk 2 X Slope (%)	N/A

N/A	Ramp inside XWalk1?	N/A	N/A	Ramp inside XWalk2?	N/A
	Road Slope (%)	N/A	N/A	Clear Space?	N/A
	Road X Slope (%)	N/A	N/A	Clear Space to XWalk (in)	N/A
N/A	Any Obstructions?	N/A	N/A	Storm Grate/Utility Hazard?	N/A
	Obstruction Type			Storm Grate/Utility Type	
		N/A			N/A
			Yes	Surface Condition? (G/P)	Good

**Remove & Replace Entire Ramp.**
