# Access Compliance Report

## Public Rights-of-Way

### (Curb Ramps)

Intersection ID: N/A	Main Street: BROOKVALE_ST	Cross Street: HORACE_ST	Location: NE
ADA ID: 28D10DEE81FE	Ramp Type: Perp	Initial Pass/Fail: Fail	Overall Compliance: No
Severity Score: 12.5			
Codes/Mitigation Info/Possible Solution		Field Measurements/Component Compliance

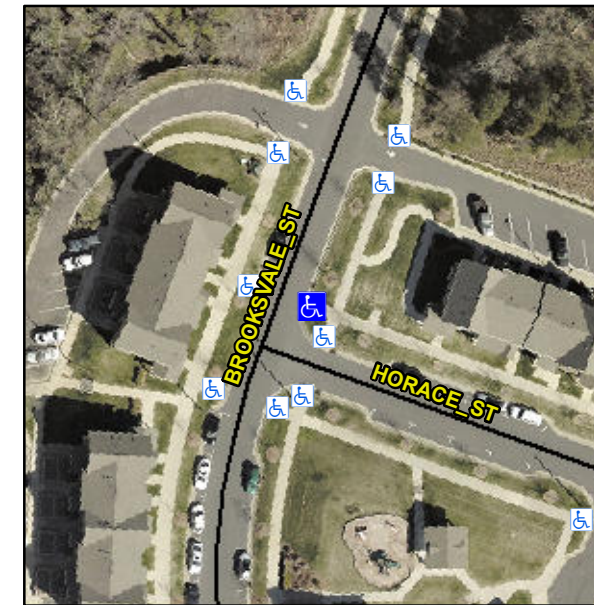
**Not Found, R304.2.2**

Compliance	Description	Data	Compliance	Description	Data
N/A	Ramp Length (in)	73.0	No	Ramp Slope (%)	9.1
Yes	Ramp Width (in)	70.0	Yes	Ramp XSlope (%)	0.1
N/A	Flare Type LT	N/A	N/A	Flare Type RT	N/A
N/A	Flare Slope LT (%)	N/A	N/A	Flare Slope RT (%)	N/A
N/A	Flare Traversable LT?	N/A	N/A	Flare Traversable RT?	N/A
N/A	Landing Length (in)	N/A	N/A	DWS Provided?	N/A
N/A	Landing Width (in)	N/A	N/A	DWS Contrast?	N/A
N/A	Landing Slope (%)	N/A	N/A	DWS Length (in)	N/A
N/A	Landing X Slope (%)	N/A	N/A	DWS Full Width?	N/A
N/A	Landing Curb? (Y/N)	N/A	N/A	DWS Offset (in)	N/A
N/A	Shared Landing?	N/A			
N/A	Gutter Ponding?	N/A	N/A	Gutter Slope (%)	N/A
N/A	Gutter Lip Ht (in)	N/A	N/A	Gutter X Slope (%)	N/A
N/A	Painted X Walk1?	No	N/A	Painted X Walk2?	N/A
	X Walk 1 Direction	To NW		X Walk 2 Direction	N/A
N/A	X Walk 1 Width (in)	N/A	N/A	X Walk 2 Width (in)	N/A
	X Walk 1 Slope (%)	0.9		X Walk 2 Slope (%)	N/A
	X Walk 1 X Slope (%)	0.8		X Walk 2 X Slope (%)	N/A

**Remove & Replace Entire Ramp.**
