# Access Compliance Report

## Public Rights-of-Way

### (Curb Ramps)

Intersection ID: 31549	Main Street: CROSS_ST	Cross Street: RED_SHED_LN	Location: SE
ADA ID: 28D35A6055DC	Ramp Type: PerpDiag	Initial Pass/Fail: Fail	Overall Compliance: No
Severity Score: 25			
Codes/Mitigation Info/Possible Solution		Field Measurements/Component Compliance

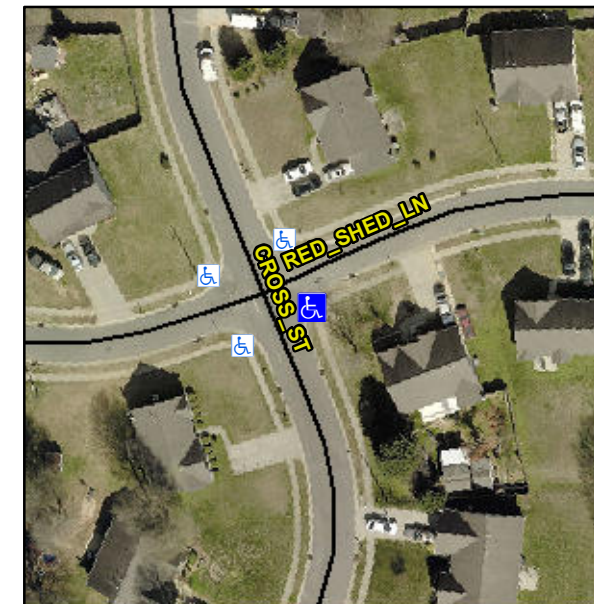
**Not Found, R304.2.2, R304.5.3**

Compliance	Description	Data	Compliance	Description	Data
N/A	Ramp Length (in)	48.0	No	Ramp Slope (%)	9.2
Yes	Ramp Width (in)	48.0	No	Ramp XSlope (%)	5.6
N/A	Flare Type LT	N/A	N/A	Flare Type RT	N/A
N/A	Flare Slope LT (%)	N/A	N/A	Flare Slope RT (%)	N/A
N/A	Flare Traversable LT?	N/A	N/A	Flare Traversable RT?	N/A
N/A	Landing Length (in)	N/A	N/A	DWS Provided?	N/A
N/A	Landing Width (in)	N/A	N/A	DWS Contrast?	N/A
N/A	Landing Slope (%)	N/A	N/A	DWS Length (in)	N/A
N/A	Landing X Slope (%)	N/A	N/A	DWS Full Width?	N/A
N/A	Landing Curb? (Y/N)	N/A	N/A	DWS Offset (in)	N/A
N/A	Shared Landing?	N/A			
N/A	Gutter Ponding?	N/A	N/A	Gutter Slope (%)	N/A
N/A	Gutter Lip Ht (in)	N/A	N/A	Gutter X Slope (%)	N/A
N/A	Painted X Walk1?	No	N/A	Painted X Walk2?	No
	X Walk 1 Direction	To N		X Walk 2 Direction	To W
N/A	X Walk 1 Width (in)	N/A	N/A	X Walk 2 Width (in)	N/A
	X Walk 1 Slope (%)	1.1		X Walk 2 Slope (%)	6.8
	X Walk 1 X Slope (%)	3.6		X Walk 2 X Slope (%)	0.7

N/A	Ramp inside XWalk1?	N/A	N/A	Ramp inside XWalk2?	N/A
	Road Slope (%)	2.3	N/A	Clear Space?	N/A
	Road X Slope (%)	3.1	N/A	Clear Space to XWalk (in)	N/A
N/A	Any Obstructions?	N/A	N/A	Storm Grate/Utility Hazard?	N/A
	Obstruction Type			Storm Grate/Utility Type	
		N/A			N/A
		Yes		Surface Condition? (G/P)	Good

**Remove & Replace Curb Ramp With Two New Directional Ramps or Equivalent.**
