Access Compliance Report

Public Rights-of-Way

(Curb Ramps)

Intersection ID: 12928	Main Street: PENMAN_ST	Cross Street: QUINCEY_ST	Location:	N
ADA ID: 28F9639F1CF0	Ramp Type: PerpDiag	Initial Pass/Fail: Fail	Overall Compliance: No	Severity Score: 12.5

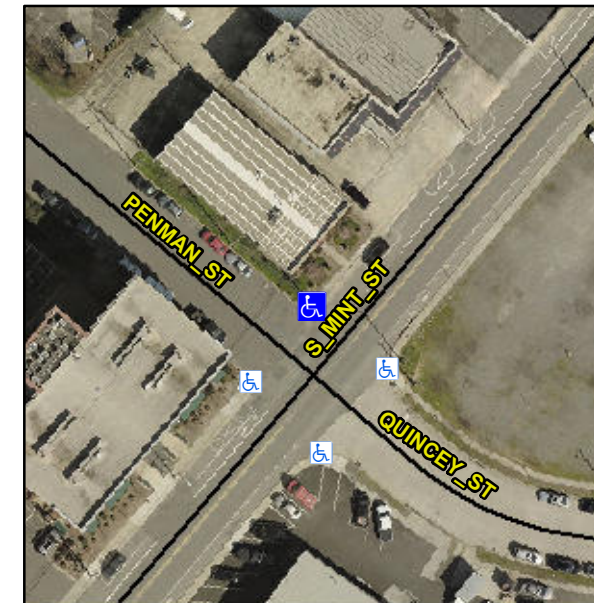
Compliance	Description	Data	Compliance	Description	Data
N/A	Ramp Length (in)	48.0	No	Ramp Slope (%)	9.6
Yes	Ramp Width (in)	48.0	Yes	Ramp XSlope (%)	1.6
N/A	Flare Type LT	N/A	N/A	Flare Type RT	N/A
N/A	Flare Slope LT (%)	N/A	N/A	Flare Slope RT (%)	N/A
N/A	Flare Traversable LT?	N/A	N/A	Flare Traversable RT?	N/A
N/A	Landing Length (in)	N/A	N/A	DWS Provided?	N/A
N/A	Landing Width (in)	N/A	N/A	DWS Contrast?	N/A
N/A	Landing Slope (%)	N/A	N/A	DWS Length (in)	N/A
N/A	Landing X Slope (%)	N/A	N/A	DWS Full Width?	N/A
N/A	Landing Curb? (Y/N)	N/A	N/A	DWS Offset (in)	N/A
N/A	Shared Landing?	N/A			
N/A	Gutter Ponding?	N/A	N/A	Gutter Slope (%)	N/A
N/A	Gutter Lip Ht (in)	N/A	N/A	Gutter X Slope (%)	N/A
N/A	Painted X Walk1?	No	N/A	Painted X Walk2?	No
	X Walk 1 Direction	To SW		X Walk 2 Direction	To SE
N/A	X Walk 1 Width (in)	N/A	N/A	X Walk 2 Width (in)	N/A
	X Walk 1 Slope (%)	3.6		X Walk 2 Slope (%)	3.2
	X Walk 1 X Slope (%)	0.5		X Walk 2 X Slope (%)	1.6

N/A	Ramp inside XWalk1?	N/A	N/A	Ramp inside XWalk2?	N/A
	Road Slope (%)	1.9	N/A	Clear Space?	N/A
	Road X Slope (%)	5.4	N/A	Clear Space to XWalk (in)	N/A
N/A	Any Obstructions?	N/A	N/A	Storm Grate/Utility Hazard?	N/A
	Obstruction Type			Storm Grate/Utility Type	
		N/A			N/A
		Yes		Surface Condition? (G/P)	Good

Possible Solutions:

Remove & Replace Curb Ramp With Two New Directional Ramps or Equivalent.

R304.2.2

\$ 3200.00
