# Access Compliance Report

## Public Rights-of-Way

Intersection ID: 15158	Main Street: ALBEMARLE_RD	Cross Street: WILORA_LAKE_RD	Location: NE
ADA ID: 28FB8FBFCE78	Ramp Type: Perp	Initial Pass/Fail: Fail	Overall Compliance: No
Severity Score: 21.25			
Codes/Mitigation Info/Possible Solution		Field Measurements/Component Compliance

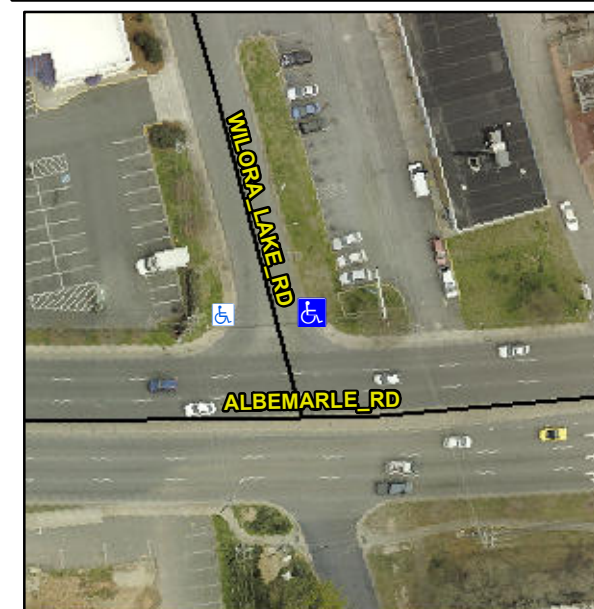
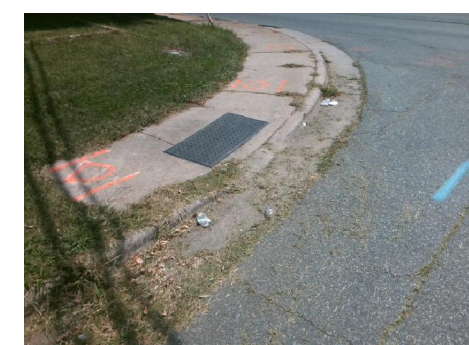
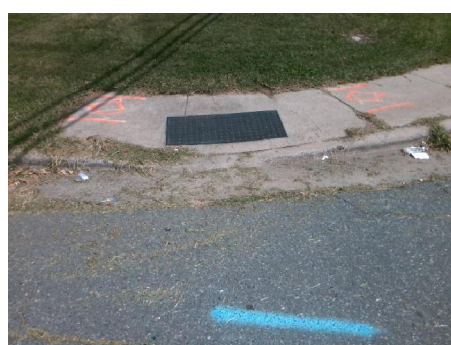
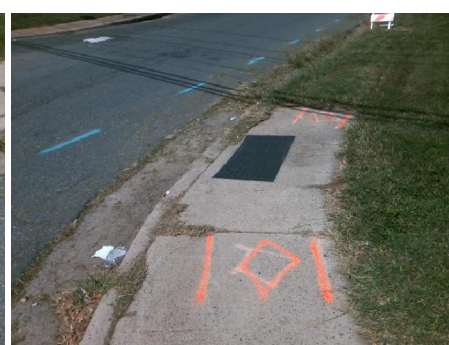
**Not Found, R304.5.1, R304.2.2**

Compliance	Description	Data	Compliance	Description	Data
N/A	Ramp Length (in)	60.0	No	Ramp Slope (%)	9.1
No	Ramp Width (in)	42.0	Yes	Ramp XSlope (%)	1.0
N/A	Flare Type LT	N/A	N/A	Flare Type RT	N/A
N/A	Flare Slope LT (%)	N/A	N/A	Flare Slope RT (%)	N/A
N/A	Flare Traversable LT?	N/A	N/A	Flare Traversable RT?	N/A
N/A	Landing Length (in)	N/A	N/A	DWS Provided?	N/A
N/A	Landing Width (in)	N/A	N/A	DWS Contrast?	N/A
N/A	Landing Slope (%)	N/A	N/A	DWS Length (in)	N/A
N/A	Landing X Slope (%)	N/A	N/A	DWS Full Width?	N/A
N/A	Landing Curb? (Y/N)	N/A	N/A	DWS Offset (in)	N/A
N/A	Shared Landing?	N/A			
N/A	Gutter Ponding?	N/A	N/A	Gutter Slope (%)	N/A
N/A	Gutter Lip Ht (in)	N/A	N/A	Gutter X Slope (%)	N/A
N/A	Painted X Walk1?	No	N/A	Painted X Walk2?	N/A
	X Walk 1 Direction	To W		X Walk 2 Direction	N/A
N/A	X Walk 1 Width (in)	N/A	N/A	X Walk 2 Width (in)	N/A
	X Walk 1 Slope (%)	0.2		X Walk 2 Slope (%)	N/A
	X Walk 1 X Slope (%)	1.8		X Walk 2 X Slope (%)	N/A

N/A	Ramp inside XWalk1?	N/A	N/A	Ramp inside XWalk2?	N/A
	Road Slope (%)	N/A	N/A	Clear Space?	N/A
	Road X Slope (%)	N/A	N/A	Clear Space to XWalk (in)	N/A
N/A	Any Obstructions?	N/A	N/A	Storm Grate/Utility Hazard?	N/A
	Obstruction Type			Storm Grate/Utility Type	
		N/A			N/A
			Yes	Surface Condition? (G/P)	Good

**Remove & Replace Entire Ramp.**
