Access Compliance Report

Public Rights-of-Way

(Curb Ramps)

Intersection ID: 11972	Main Street: N_POPLAR_ST	Cross Street: W_5TH_ST	Location: N
ADA ID: 28FC4214A6C4	Ramp Type: BlendTrans1	Initial Pass/Fail: Fail	Overall Compliance: No
			Severity Score: 21.25

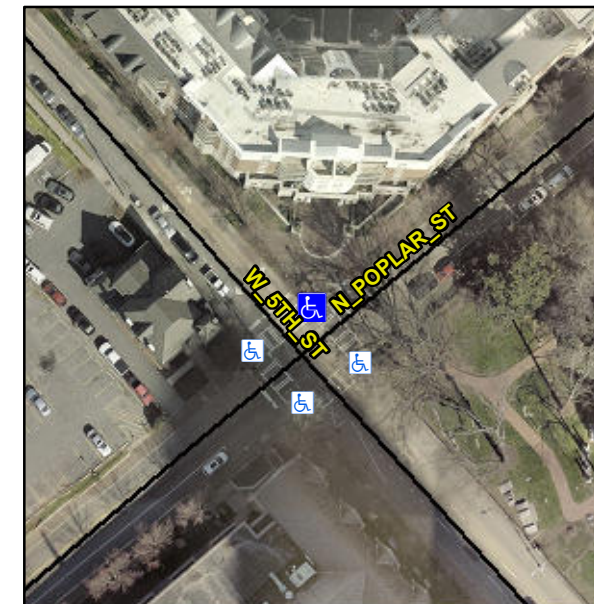
Not Found, R304.5.1, R304.5.3

Compliance	Description	Data	Compliance	Description	Data
N/A	Ramp Length (in)	75.0	Yes	BlendTrans Slope (%)	2.0
No	Ramp Width (in)	39.0	No	BlendTrans XSlope (%)	5.7
N/A	Flare Type LT	N/A	N/A	Flare Type RT	N/A
N/A	Flare Slope LT (%)	N/A	N/A	Flare Slope RT (%)	N/A
N/A	Flare Traversable LT?	N/A	N/A	Flare Traversable RT?	N/A
N/A	Landing Length (in)	N/A	N/A	DWS Provided?	N/A
N/A	Landing Width (in)	N/A	N/A	DWS Contrast?	N/A
N/A	Landing Slope (%)	N/A	N/A	DWS Length (in)	N/A
N/A	Landing X Slope (%)	N/A	N/A	DWS Full Width?	N/A
N/A	Landing Curb? (Y/N)	N/A	N/A	DWS Offset (in)	N/A
N/A	Shared Landing?	N/A			
N/A	Gutter Ponding?	N/A	N/A	Gutter Slope (%)	N/A
N/A	Gutter Lip Ht (in)	N/A	N/A	Gutter X Slope (%)	N/A
N/A	Painted X Walk1?	Yes	N/A	Painted X Walk2?	Yes
	X Walk 1 Direction	To SW		X Walk 2 Direction	To SE
	X Walk 1 Width (in)	110.0		X Walk 2 Width (in)	112.0
	X Walk 1 Slope (%)	6.2		X Walk 2 Slope (%)	2.6
	X Walk 1 X Slope (%)	0.1		X Walk 2 X Slope (%)	3.6

N/A	Ramp inside XWalk1?	Yes	N/A	Ramp inside XWalk2?	Yes
	Road Slope (%)	1.0		Clear Space?	N/A
	Road X Slope (%)	8.0	N/A	Clear Space to XWalk (in)	N/A
N/A	Any Obstructions?	N/A	N/A	Storm Grate/Utility Hazard?	N/A
	Obstruction Type			Storm Grate/Utility Type	
		N/A			N/A
			Yes	Surface Condition? (G/P)	Good
			No	Curb Slope (%)	5.3

Remove & Replace Curb Ramp With Two New Directional Ramps or Equivalent.
