Access Compliance Report

Public Rights-of-Way

(Curb Ramps)

Intersection ID: 10443	Main Street: JORDAN_PL	Cross Street: N_BREVARD_ST	Location: W
ADA ID: 2900F0640C8B	Ramp Type: Combination1	Initial Pass/Fail: Fail	Overall Compliance: No
		Severity Score: 10

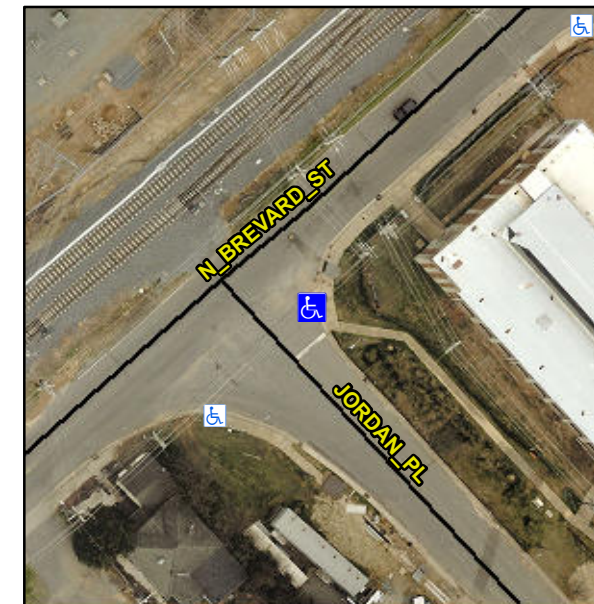
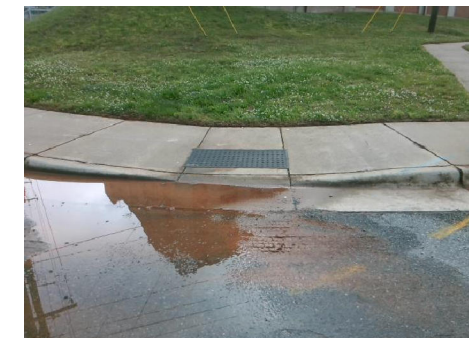
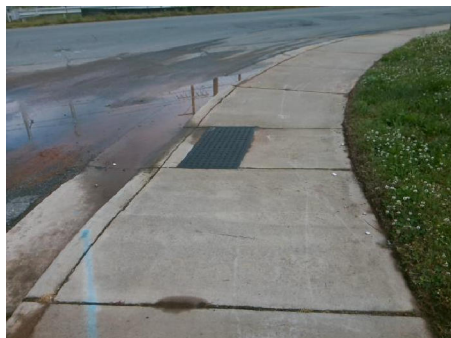
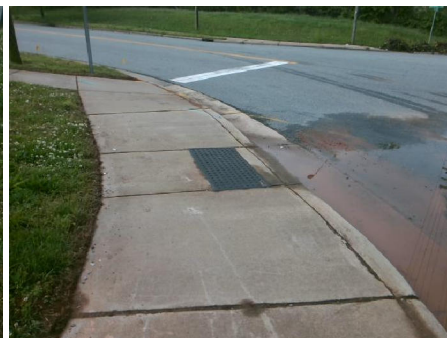
LT RP < 5%

Not Found, R304.5.1, R304.5.3

Compliance	Description	Data	Compliance	Description	Data
N/A	Ramp Length LT (in)	54.5	N/A	Ramp Length RT (in)	63.0
Yes	Ramp Width LT (in)	71.0	Yes	Ramp Width RT (in)	70.5
Yes	Ramp Slope LT (%)	3.1	Yes	Ramp Slope RT (%)	6.3
No	Ramp XSlope LT (%)	4.2	No	Ramp XSlope RT (%)	3.3
N/A	Ramp Length (in)	70.5	Yes	Ramp Slope (%)	6.8
No	Ramp Width (in)	42.5	No	Ramp XSlope (%)	2.2
N/A	Flare Type LT	N/A	N/A	Flare Type RT	N/A
N/A	Flare Slope LT (%)	N/A	N/A	Flare Slope RT (%)	N/A
N/A	Flare Traversable LT?	N/A	N/A	Flare Traversable RT?	N/A
N/A	Landing Length (in)	N/A	N/A	DWS Provided?	N/A
N/A	Landing Width (in)	N/A	N/A	DWS Contrast?	N/A
N/A	Landing Slope (%)	N/A	N/A	DWS Length (in)	N/A
N/A	Landing X Slope (%)	N/A	N/A	DWS Full Width?	N/A
N/A	Landing Curb? (Y/N)	N/A	N/A	DWS Offset (in)	N/A
N/A	Shared Landing?	N/A			
N/A	Gutter Ponding?	N/A	N/A	Gutter Slope (%)	N/A
N/A	Gutter Lip Ht (in)	N/A	N/A	Gutter X Slope (%)	N/A
N/A	Painted X Walk1?	No	N/A	Painted X Walk2?	N/A

Possible Solutions:

Remove & Replace Entire Ramp.
