Access Compliance Report Public Rights-of-Way (Curb Ramps)

Intersection ID: 18705 Main Street: HAVEL_CT Cross Street: KIRKPATRICK_RD Location: E

ADA ID: 2906DE2B496D Ramp Type: Perp Initial Pass/Fail: Pass Overall Compliance: No Severity Score: 10

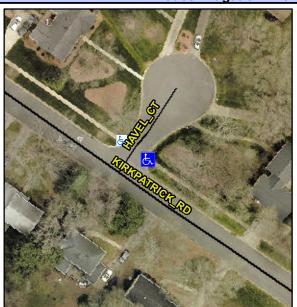
| Possible Solutions: | Co |
|---|---|
| Not Found, R305 | Yes |

| Field Measurements/Component Compilance | | | | | | | |
|---|---|---|---|---|---|---|--|
| | Yes | Landing Length (in) | 51.0 | No | DWS Provided? | No | |
| | Yes | Landing Width (in) | 48.0 | N/A | DWS Contrast? | No | |

| Possible Solutions: | Co |
|---|---|
| Remove & Replace Entire Ramp. | N/A |

| Total Cost: | \$ 1850.00 |
