# Access Compliance Report

## Public Rights-of-Way

### (Curb Ramps)

Intersection ID: 48949	Main Street: OLD_STONE_CROSSING_DR	Cross Street: DAVID_JENNINGS_AV	Location: NW
ADA ID: 291B0DB3BCED	Ramp Type: Combination1	Initial Pass/Fail: Fail	Overall Compliance: No
			Severity Score: 46.25

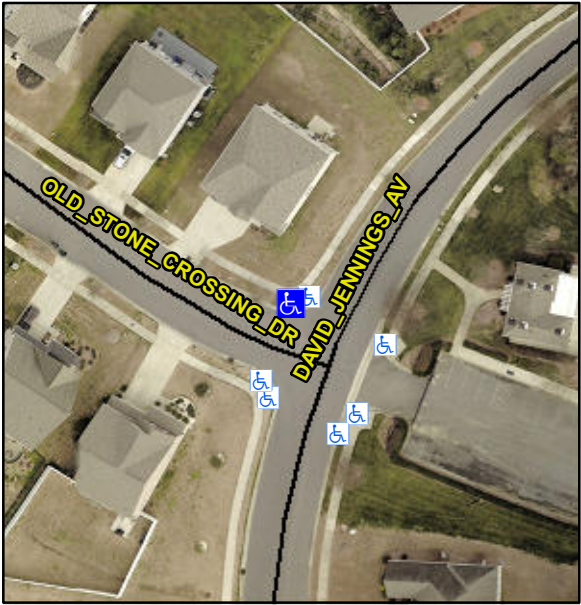
Possible Solutions:		<b>Compliance</b>	<b>Description</b>	<b>Data</b>
	<b>Remove &amp; Replace Entire Ramp.</b>		<b>N/A</b>	Ramp Length LT (in)	<b>3.5</b>
			<b>Yes</b>	Ramp Width LT (in)	<b>60.0</b>
			<b>No</b>	Ramp Slope LT (%)	<b>14.4</b>
			<b>No</b>	Ramp XSlope LT (%)	<b>2.3</b>
			<b>N/A</b>	Ramp Length (in)	<b>70.0</b>
			<b>No</b>	Ramp Width (in)	<b>47.0</b>
			<b>N/A</b>	Flare Type LT	<b>N/A</b>
			<b>N/A</b>	Flare Slope LT (%)	<b>N/A</b>
			<b>N/A</b>	Flare Traversable LT?	<b>N/A</b>
<p>Surveyor Notes:</p> <p><b>N/A</b></p> <p>PROW/ADA:</p> <p><b>Not Found, R304.5.1, R304.5.3, R304.3.2</b></p>			<b>N/A</b>	Ramp Slope RT (%)	<b>9.6</b>
			<b>Yes</b>	Ramp XSlope RT (%)	<b>0.6</b>
			<b>Yes</b>	Ramp Slope (%)	<b>1.4</b>
			<b>No</b>	Ramp XSlope (%)	<b>5.5</b>
			<b>N/A</b>	Flare Type RT	<b>N/A</b>
			<b>N/A</b>	Flare Slope RT (%)	<b>N/A</b>
