Access Compliance Report

Public Rights-of-Way

(Curb Ramps)

Intersection ID: N/A	Main Street: SHOPTON_RD	Cross Street: ROCK_ISLAND_RD	Location: NE
ADA ID: 2924FCA09AC9	Ramp Type: Perp	Initial Pass/Fail: Fail	Overall Compliance: No
Severity Score: 21.25			
Codes/Mitigation Info/Possible Solution		Field Measurements/Component Compliance

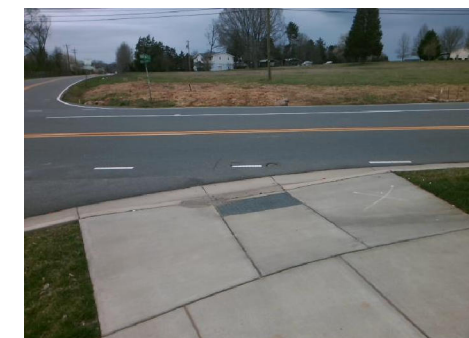
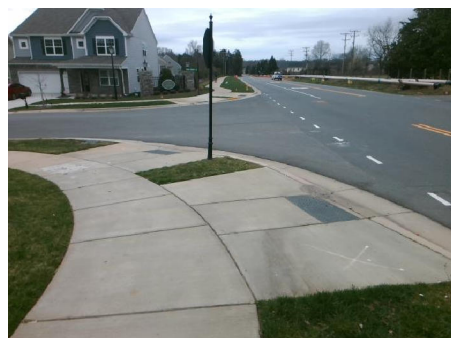
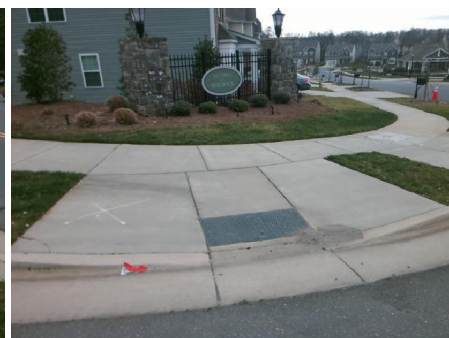
Compliance	Description	Data	Compliance	Description	Data
N/A	Ramp Length (in)	89.0	Yes	Ramp Slope (%)	5.6
No	Ramp Width (in)	46.5	No	Ramp XSlope (%)	5.3
N/A	Flare Type LT	N/A	N/A	Flare Type RT	N/A
N/A	Flare Slope LT (%)	N/A	N/A	Flare Slope RT (%)	N/A
N/A	Flare Traversable LT?	N/A	N/A	Flare Traversable RT?	N/A
N/A	Landing Length (in)	N/A	N/A	DWS Provided?	N/A
N/A	Landing Width (in)	N/A	N/A	DWS Contrast?	N/A
N/A	Landing Slope (%)	N/A	N/A	DWS Length (in)	N/A
N/A	Landing X Slope (%)	N/A	N/A	DWS Full Width?	N/A
N/A	Landing Curb? (Y/N)	N/A	N/A	DWS Offset (in)	N/A
N/A	Shared Landing?	N/A			
N/A	Gutter Ponding?	N/A	N/A	Gutter Slope (%)	N/A
N/A	Gutter Lip Ht (in)	N/A	N/A	Gutter X Slope (%)	N/A
N/A	Painted X Walk1?	No	N/A	Painted X Walk2?	N/A
	X Walk 1 Direction	To NW		X Walk 2 Direction	N/A
N/A	X Walk 1 Width (in)	N/A	N/A	X Walk 2 Width (in)	N/A
	X Walk 1 Slope (%)	5.7		X Walk 2 Slope (%)	N/A
	X Walk 1 X Slope (%)	2.3		X Walk 2 X Slope (%)	N/A

N/A	Ramp inside XWalk1?	N/A	N/A	Ramp inside XWalk2?	N/A
	Road Slope (%)	N/A	N/A	Clear Space?	N/A
	Road X Slope (%)	N/A	N/A	Clear Space to XWalk (in)	N/A
N/A	Any Obstructions?	N/A	N/A	Storm Grate/Utility Hazard?	N/A
	Obstruction Type			Storm Grate/Utility Type	
		N/A			N/A
			Yes	Surface Condition? (G/P)	Good

Possible Solutions:

Remove & Replace Entire Ramp.

PROW/ADA:

R304.5.1, R304.5.3

Total Cost: \$ 1850.00
