# Access Compliance Report

## Public Rights-of-Way

### (Curb Ramps)

Intersection ID: 10671	Main Street: PLYMOUTH_AV	Cross Street: GRIMES_ST	Location:	N
ADA ID: 29559698FE59	Ramp Type: PerpDiag	Initial Pass/Fail: Fail	Overall Compliance: No	Severity Score: 13.75
Codes/Mitigation Info/Possible Solution		Field Measurements/Component Compliance

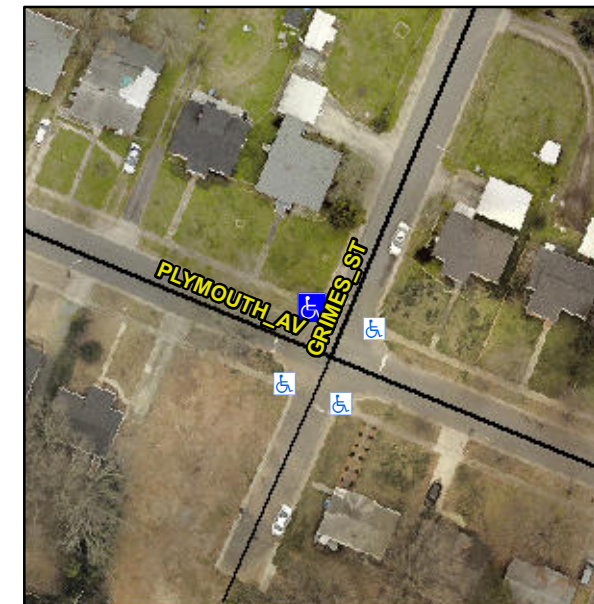
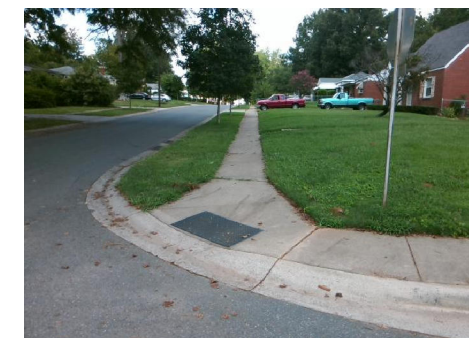
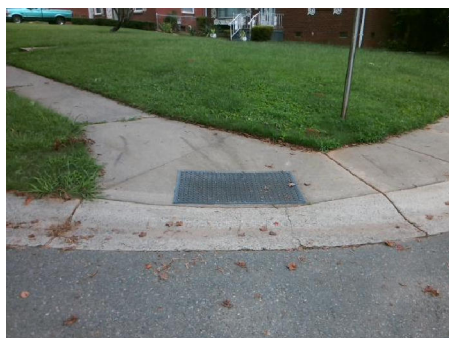
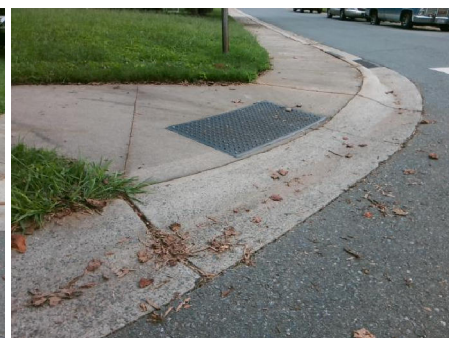
**Not Found, R304.2.2, R304.5.3**

Compliance	Description	Data	Compliance	Description	Data
N/A	Ramp Length (in)	37.5	No	Ramp Slope (%)	9.5
Yes	Ramp Width (in)	48.0	No	Ramp XSlope (%)	2.4
N/A	Flare Type LT	N/A	N/A	Flare Type RT	N/A
N/A	Flare Slope LT (%)	N/A	N/A	Flare Slope RT (%)	N/A
N/A	Flare Traversable LT?	N/A	N/A	Flare Traversable RT?	N/A
N/A	Landing Length (in)	N/A	N/A	DWS Provided?	N/A
N/A	Landing Width (in)	N/A	N/A	DWS Contrast?	N/A
N/A	Landing Slope (%)	N/A	N/A	DWS Length (in)	N/A
N/A	Landing X Slope (%)	N/A	N/A	DWS Full Width?	N/A
N/A	Landing Curb? (Y/N)	N/A	N/A	DWS Offset (in)	N/A
N/A	Shared Landing?	N/A			
N/A	Gutter Ponding?	N/A	N/A	Gutter Slope (%)	N/A
N/A	Gutter Lip Ht (in)	N/A	N/A	Gutter X Slope (%)	N/A
N/A	Painted X Walk1?	No	N/A	Painted X Walk2?	No
	X Walk 1 Direction	To SW		X Walk 2 Direction	To SE
N/A	X Walk 1 Width (in)	N/A	N/A	X Walk 2 Width (in)	N/A
	X Walk 1 Slope (%)	3.6		X Walk 2 Slope (%)	0.2
	X Walk 1 X Slope (%)	2.5		X Walk 2 X Slope (%)	0.4

N/A	Ramp inside XWalk1?	N/A	N/A	Ramp inside XWalk2?	N/A
	Road Slope (%)	0.4	N/A	Clear Space?	N/A
	Road X Slope (%)	0.2	N/A	Clear Space to XWalk (in)	N/A
N/A	Any Obstructions?	N/A	N/A	Storm Grate/Utility Hazard?	N/A
	Obstruction Type			Storm Grate/Utility Type	
		N/A			N/A
			Yes	Surface Condition? (G/P)	Good

**Remove & Replace Curb Ramp With Two New Directional Ramps or Equivalent.**
