# Access Compliance Report

## Public Rights-of-Way

### (Curb Ramps)

Intersection ID: 3577	Main Street: CROFTON_SPRINGS_DR	Cross Street: LAUREL_CREST_CT	Location: SW
ADA ID: 29621D1EF4F5	Ramp Type: BlendTrans1	Initial Pass/Fail: Fail	Overall Compliance: No
		Severity Score: 10

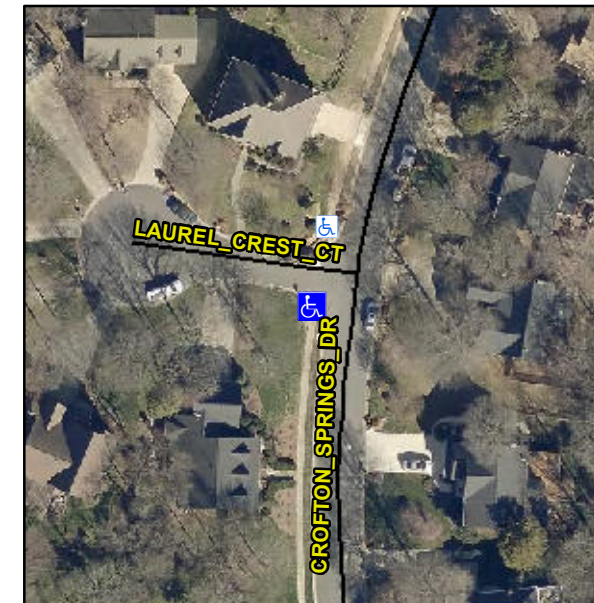
**Not Found, R304.5.1, R304.5.3**

Compliance	Description	Data	Compliance	Description	Data
N/A	Ramp Length (in)	190.0	Yes	BlendTrans Slope (%)	1.4
No	Ramp Width (in)	47.0	No	BlendTrans XSlope (%)	2.8
N/A	Flare Type LT	N/A	N/A	Flare Type RT	N/A
N/A	Flare Slope LT (%)	N/A	N/A	Flare Slope RT (%)	N/A
N/A	Flare Traversable LT?	N/A	N/A	Flare Traversable RT?	N/A
N/A	Landing Length (in)	N/A	N/A	DWS Provided?	N/A
N/A	Landing Width (in)	N/A	N/A	DWS Contrast?	N/A
N/A	Landing Slope (%)	N/A	N/A	DWS Length (in)	N/A
N/A	Landing X Slope (%)	N/A	N/A	DWS Full Width?	N/A
N/A	Landing Curb? (Y/N)	N/A	N/A	DWS Offset (in)	N/A
N/A	Shared Landing?	N/A			
N/A	Gutter Ponding?	N/A	N/A	Gutter Slope (%)	N/A
N/A	Gutter Lip Ht (in)	N/A	N/A	Gutter X Slope (%)	N/A
N/A	Painted X Walk1?	No	N/A	Painted X Walk2?	N/A
	X Walk 1 Direction	To N		X Walk 2 Direction	N/A
	X Walk 1 Width (in)	N/A		X Walk 2 Width (in)	N/A
	X Walk 1 Slope (%)	2.1		X Walk 2 Slope (%)	N/A
	X Walk 1 X Slope (%)	2.5		X Walk 2 X Slope (%)	N/A

N/A	Ramp inside XWalk1?	N/A	N/A	Ramp inside XWalk2?	N/A
	Road Slope (%)	2.5		Clear Space?	N/A
	Road X Slope (%)	2.1	N/A	Clear Space to XWalk (in)	N/A
N/A	Any Obstructions?	N/A	N/A	Storm Grate/Utility Hazard?	N/A
	Obstruction Type			Storm Grate/Utility Type	
		N/A			N/A
			Yes	Surface Condition? (G/P)	Good
			No	Curb Slope (%)	30.5

**Remove & Replace Curb Ramp With Two New Directional Ramps or Equivalent.**
