Access Compliance Report

Public Rights-of-Way

(Curb Ramps)

Intersection ID: 10020374	Main Street: BALLANTYNE CORPORATE PL	Cross Street: N/A	Location: S
ADA ID: 2978CC1BADF7	Ramp Type: Perp	Initial Pass/Fail: Pass	Overall Compliance: No
			Severity Score: 0.25
Codes/Mitigation Info/Possible Solution		Field Measurements/Component Compliance

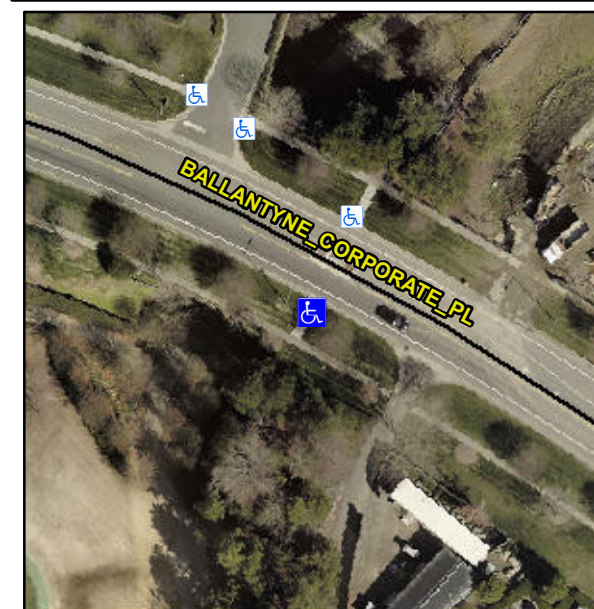
Compliance	Description	Data	Compliance	Description	Data
N/A	Ramp Length (in)	258.0	Yes	Ramp Slope (%)	6.6
Yes	Ramp Width (in)	60.0	Yes	Ramp XSlope (%)	2.4
Yes	Flare Type L	Curbed_NoWalkSurface	Yes	Flare Type RT	N/A
Yes	Flare Slope LT (%)	N/A	N/A	Flare Slope RT (%)	N/A
N/A	Flare Traversable LT?	No	N/A	Flare Traversable RT?	No
Yes	Landing Length (in)	48.0	Yes	DWS Provided?	Yes
Yes	Landing Width (in)	60.0	Yes	DWS Contrast?	Yes
Yes	Landing Slope (%)	1.5	Yes	DWS Length (in)	24.0
No	Landing X Slope (%)	3.6	Yes	DWS Full Width?	Yes
N/A	Landing Curb? (Y/N)	No	Yes	DWS Offset (in)	0.0
N/A	Shared Landing?	No			
Yes	Gutter Ponding?	No	Yes	Gutter Slope (%)	3.1
Yes	Gutter Lip Ht (in)	0.0	Yes	Gutter X Slope (%)	2.0
N/A	Painted X Walk1?	No	N/A	Painted X Walk2?	N/A
	X Walk 1 Direction	To NE		X Walk 2 Direction	N/A
N/A	X Walk 1 Width (in)	N/A	N/A	X Walk 2 Width (in)	N/A
	X Walk 1 Slope (%)	3.3		X Walk 2 Slope (%)	N/A
	X Walk 1 X Slope (%)	2.4		X Walk 2 X Slope (%)	N/A

N/A	Ramp inside XWalk1?	N/A	N/A	Ramp inside XWalk2?	N/A
	Road Slope (%)	N/A	N/A	Clear Space?	Yes
	Road X Slope (%)	N/A	N/A	Clear Space to XWalk (in)	N/A
Yes	Any Obstructions?	No	Yes	Storm Grate/Utility Hazard?	No
	Obstruction Type			Storm Grate/Utility Type	
		N/A			N/A
			Yes	Surface Condition? (G/P)	Good

Possible Solutions:

Remove & Replace Landing.

PROW/ADA:

R304.5.3
