# Access Compliance Report

## Public Rights-of-Way

### (Curb Ramps)

Intersection ID: 15291	Main Street: OLD_MEADOW_RD	Cross Street: SPRINGBEAUTY_DR	Location: SW
ADA ID: 29893E2F681C	Ramp Type: PerpDiag	Initial Pass/Fail: Fail	Overall Compliance: No
Severity Score: 12.5			
Codes/Mitigation Info/Possible Solution		Field Measurements/Component Compliance

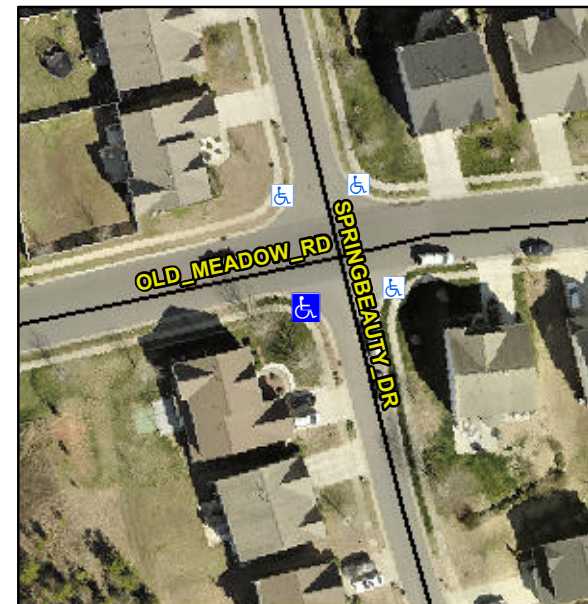
**Not Found, R304.5.3**

Compliance	Description	Data	Compliance	Description	Data
N/A	Ramp Length (in)	48.0	Yes	Ramp Slope (%)	5.7
Yes	Ramp Width (in)	48.0	No	Ramp XSlope (%)	6.8
N/A	Flare Type LT	N/A	N/A	Flare Type RT	N/A
N/A	Flare Slope LT (%)	N/A	N/A	Flare Slope RT (%)	N/A
N/A	Flare Traversable LT?	N/A	N/A	Flare Traversable RT?	N/A
N/A	Landing Length (in)	N/A	N/A	DWS Provided?	N/A
N/A	Landing Width (in)	N/A	N/A	DWS Contrast?	N/A
N/A	Landing Slope (%)	N/A	N/A	DWS Length (in)	N/A
N/A	Landing X Slope (%)	N/A	N/A	DWS Full Width?	N/A
N/A	Landing Curb? (Y/N)	N/A	N/A	DWS Offset (in)	N/A
N/A	Shared Landing?	N/A			
N/A	Gutter Ponding?	N/A	N/A	Gutter Slope (%)	N/A
N/A	Gutter Lip Ht (in)	N/A	N/A	Gutter X Slope (%)	N/A
N/A	Painted X Walk1?	No	N/A	Painted X Walk2?	No
	X Walk 1 Direction	To E		X Walk 2 Direction	To N
N/A	X Walk 1 Width (in)	N/A	N/A	X Walk 2 Width (in)	N/A
	X Walk 1 Slope (%)	5.3		X Walk 2 Slope (%)	4.9
	X Walk 1 X Slope (%)	5.0		X Walk 2 X Slope (%)	5.6

N/A	Ramp inside XWalk1?	N/A	N/A	Ramp inside XWalk2?	N/A
	Road Slope (%)	7.6	N/A	Clear Space?	N/A
	Road X Slope (%)	2.2	N/A	Clear Space to XWalk (in)	N/A
N/A	Any Obstructions?	N/A	N/A	Storm Grate/Utility Hazard?	N/A
	Obstruction Type			Storm Grate/Utility Type	
		N/A			N/A
		Yes		Surface Condition? (G/P)	Good

**Remove & Replace Curb Ramp With Two New Directional Ramps or Equivalent.**

Total Cost: \$ **3200.00**
