Access Compliance Report

Public Rights-of-Way

(Curb Ramps)

Intersection ID: N/A	Main Street: HAMILTON_BRIDGE_RD	Cross Street: OBAN_PASSAGE_DR	Location: SE
ADA ID: 29A883DABF12	Ramp Type: Perp	Initial Pass/Fail: Fail	Overall Compliance: No
Severity Score: 58.75			
Codes/Mitigation Info/Possible Solution		Field Measurements/Component Compliance

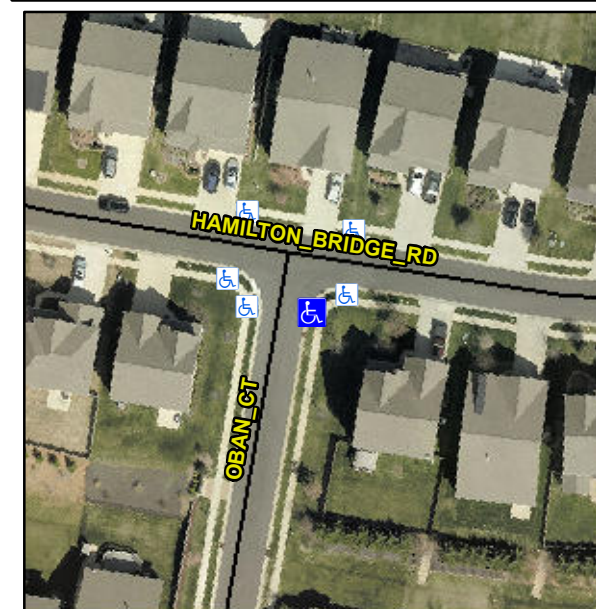
Compliance	Description	Data	Compliance	Description	Data
N/A	Ramp Length (in)	47.0	No	Ramp Slope (%)	15.1
No	Ramp Width (in)	45.0	No	Ramp XSlope (%)	7.9
N/A	Flare Type LT	N/A	N/A	Flare Type RT	N/A
N/A	Flare Slope LT (%)	N/A	N/A	Flare Slope RT (%)	N/A
N/A	Flare Traversable LT?	N/A	N/A	Flare Traversable RT?	N/A
N/A	Landing Length (in)	N/A	N/A	DWS Provided?	N/A
N/A	Landing Width (in)	N/A	N/A	DWS Contrast?	N/A
N/A	Landing Slope (%)	N/A	N/A	DWS Length (in)	N/A
N/A	Landing X Slope (%)	N/A	N/A	DWS Full Width?	N/A
N/A	Landing Curb? (Y/N)	N/A	N/A	DWS Offset (in)	N/A
N/A	Shared Landing?	N/A			
N/A	Gutter Ponding?	N/A	N/A	Gutter Slope (%)	N/A
N/A	Gutter Lip Ht (in)	1.0	N/A	Gutter X Slope (%)	N/A
N/A	Painted X Walk1?	No	N/A	Painted X Walk2?	N/A
	X Walk 1 Direction	To W		X Walk 2 Direction	N/A
N/A	X Walk 1 Width (in)	N/A	N/A	X Walk 2 Width (in)	N/A
	X Walk 1 Slope (%)	1.9		X Walk 2 Slope (%)	N/A
	X Walk 1 X Slope (%)	7.3		X Walk 2 X Slope (%)	N/A

N/A	Ramp inside XWalk1?	N/A	N/A	Ramp inside XWalk2?	N/A
	Road Slope (%)	N/A	N/A	Clear Space?	N/A
	Road X Slope (%)	N/A	N/A	Clear Space to XWalk (in)	N/A
N/A	Any Obstructions?	N/A	N/A	Storm Grate/Utility Hazard?	N/A
	Obstruction Type			Storm Grate/Utility Type	
		N/A			N/A
		Yes		Surface Condition? (G/P)	Good

Possible Solutions:

Remove & Replace Entire Ramp.

R304.5.1, R304.2.2, R304.5.3
