Intersection ID: 14600 Main Street: DILWORTH_RD Cross Street: DILWORTH_RD_EAST Location: SW

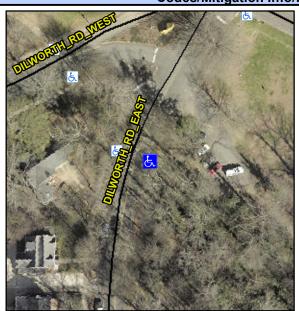
Total Cost:	\$ 1850.00

rieid Measure	ements/C	ompo	nent Compliance	
Compliance Description		Data	Comp	liance Description	Data	
	N/A	Ramp Length (in)	115.0	No	Ramp Slope (%)	9.1
	Yes	Ramp Width (in)	48.0	No	Ramp XSlope (%)	3.9
	N/A	Flare Type LT	N/A	N/A	Flare Type RT	N/A
	N/A	Flare Slope LT (%)	N/A	N/A	Flare Slope RT (%)	N/A
	N/A	Flare Traversable LT?	N/A	N/A	Flare Traversable RT?	N/A
	N/A	Landing Length (in)	N/A	N/A	DWS Provided?	N/A
	N/A	Landing Width (in)	N/A	N/A	DWS Contrast?	N/A
	N/A	Landing Slope (%)	N/A	N/A	DWS Length (in)	N/A
	N/A	Landing X Slope (%)	N/A	N/A	DWS Full Width?	N/A
	N/A	Landing Curb? (Y/N)	N/A	N/A	DWS Offset (in)	N/A
	N/A	Shared Landing?	N/A			
	N/A	Gutter Ponding?	Yes	N/A	Gutter Slope (%)	N/A
	N/A	Gutter Lip Ht (in)	N/A	N/A	Gutter X Slope (%)	N/A
	N/A	Painted X Walk1?	No	N/A	Painted X Walk2?	N/A
		X Walk 1 Direction	To W		X Walk 2 Direction	N/A
	N/A	X Walk 1 Width (in)	N/A	N/A	X Walk 2 Width (in)	N/A
		X Walk 1 Slope (%)	5.2		X Walk 2 Slope (%)	N/A

Street 1 Name DILWORTH RD EAST
Stop Condition-Street 2 None
Street 2 Name N/A
Stop Condition-Street 1 N/A
