Access Compliance Report Public Rights-of-Way (Curb Ramps)

Intersection ID: 13359 Main Street: BARRINGER DR Cross Street: S I-77 RA Location: NW

Initial Pass/Fail: Fail **Overall Compliance: No Severity Score:** ADA ID: 29D25F7417B0 Ramp Type: PerpDiag 8.75

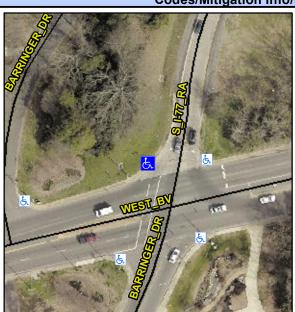
Surveyor Notes: N/A

Not Found, R304.5.1

Street 1 Name Stop Condition-Street 2 Street 2 Name Stop Condition-Street 1 Remove & Replace Curb Ramp With Two New Directional Ramps or Equivalent.
