Access Compliance Report

Public Rights-of-Way

(Curb Ramps)

Intersection ID: 12618	Main Street: E_5TH_ST	Cross Street: N_CALDWELL_ST	Location: NW
ADA ID: 2A18590F718E	Ramp Type: Perp	Initial Pass/Fail: Fail	Overall Compliance: No
		Severity Score: 12.5

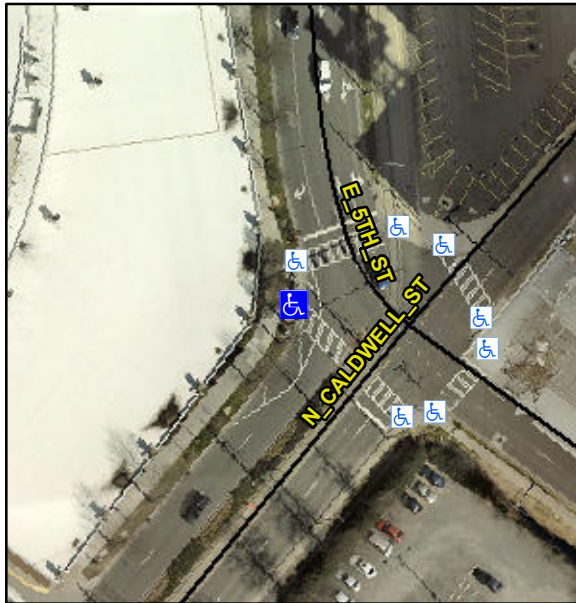
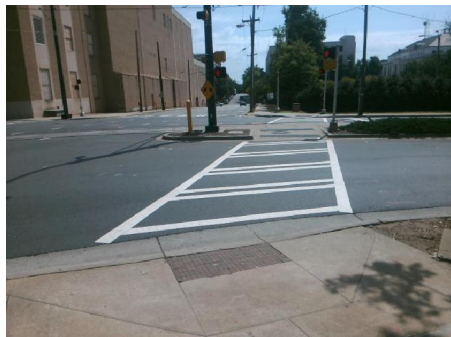
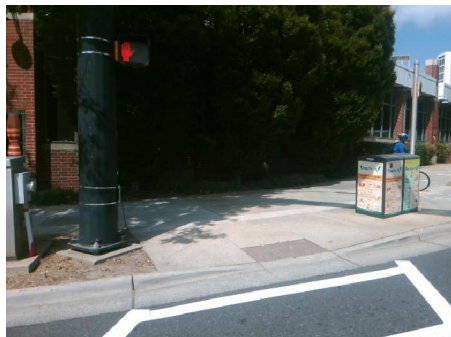
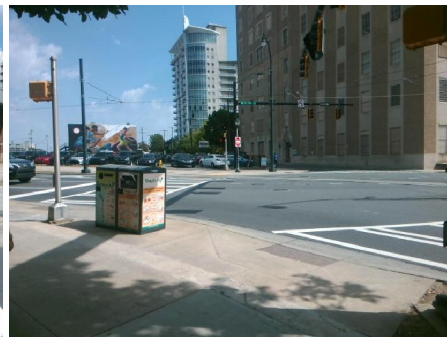
Not Found, R304.5.3

Compliance	Description	Data	Compliance	Description	Data
N/A	Ramp Length (in)	67.0	Yes	Ramp Slope (%)	7.4
Yes	Ramp Width (in)	48.0	No	Ramp XSlope (%)	5.2
N/A	Flare Type LT	N/A	N/A	Flare Type RT	N/A
N/A	Flare Slope LT (%)	N/A	N/A	Flare Slope RT (%)	N/A
N/A	Flare Traversable LT?	N/A	N/A	Flare Traversable RT?	N/A
N/A	Landing Length (in)	N/A	N/A	DWS Provided?	N/A
N/A	Landing Width (in)	N/A	N/A	DWS Contrast?	N/A
N/A	Landing Slope (%)	N/A	N/A	DWS Length (in)	N/A
N/A	Landing X Slope (%)	N/A	N/A	DWS Full Width?	N/A
N/A	Landing Curb? (Y/N)	N/A	N/A	DWS Offset (in)	N/A
N/A	Shared Landing?	N/A			
N/A	Gutter Ponding?	N/A	N/A	Gutter Slope (%)	N/A
N/A	Gutter Lip Ht (in)	N/A	N/A	Gutter X Slope (%)	N/A
N/A	Painted X Walk1?	Yes	N/A	Painted X Walk2?	N/A
	X Walk 1 Direction	To SE		X Walk 2 Direction	N/A
N/A	X Walk 1 Width (in)	128.0	N/A	X Walk 2 Width (in)	N/A
	X Walk 1 Slope (%)	0.5		X Walk 2 Slope (%)	N/A
	X Walk 1 X Slope (%)	3.8		X Walk 2 X Slope (%)	N/A

N/A	Ramp inside XWalk1?	Yes	N/A	Ramp inside XWalk2?	N/A
	Road Slope (%)	N/A	N/A	Clear Space?	N/A
	Road X Slope (%)	N/A	N/A	Clear Space to XWalk (in)	N/A
N/A	Any Obstructions?	N/A	N/A	Storm Grate/Utility Hazard?	N/A
	Obstruction Type			Storm Grate/Utility Type	
		N/A			N/A
		Yes		Surface Condition? (G/P)	Good

Possible Solutions:

Remove & Replace Entire Ramp.

Total Cost: \$ **1850.00**
