Access Compliance Report

Public Rights-of-Way

(Curb Ramps)

Intersection ID: 31296	Main Street: DEERTON_RD	Cross Street: MELSTRAND_WY	Location: E
ADA ID: 2A1BF1CC3E9D	Ramp Type: PerpDiag	Initial Pass/Fail: Fail	Overall Compliance: No
			Severity Score: 33.75

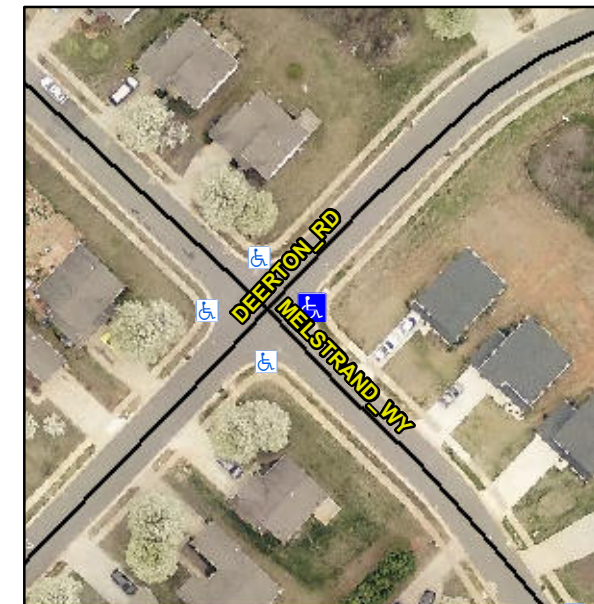
Compliance	Description	Data	Compliance	Description	Data
N/A	Ramp Length (in)	48.5	Yes	Ramp Slope (%)	7.2
No	Ramp Width (in)	45.0	No	Ramp XSlope (%)	7.3
N/A	Flare Type LT	N/A	N/A	Flare Type RT	N/A
N/A	Flare Slope LT (%)	N/A	N/A	Flare Slope RT (%)	N/A
N/A	Flare Traversable LT?	N/A	N/A	Flare Traversable RT?	N/A
N/A	Landing Length (in)	N/A	N/A	DWS Provided?	N/A
N/A	Landing Width (in)	N/A	N/A	DWS Contrast?	N/A
N/A	Landing Slope (%)	N/A	N/A	DWS Length (in)	N/A
N/A	Landing X Slope (%)	N/A	N/A	DWS Full Width?	N/A
N/A	Landing Curb? (Y/N)	N/A	N/A	DWS Offset (in)	N/A
N/A	Shared Landing?	N/A			
N/A	Gutter Ponding?	N/A	N/A	Gutter Slope (%)	N/A
N/A	Gutter Lip Ht (in)	N/A	N/A	Gutter X Slope (%)	N/A
N/A	Painted X Walk1?	No	N/A	Painted X Walk2?	No
	X Walk 1 Direction	To NW		X Walk 2 Direction	To SW
N/A	X Walk 1 Width (in)	N/A	N/A	X Walk 2 Width (in)	N/A
	X Walk 1 Slope (%)	2.7		X Walk 2 Slope (%)	7.5
	X Walk 1 X Slope (%)	7.6		X Walk 2 X Slope (%)	1.8

N/A	Ramp inside XWalk1?	N/A	N/A	Ramp inside XWalk2?	N/A
	Road Slope (%)	6.1	N/A	Clear Space?	N/A
	Road X Slope (%)	3.8	N/A	Clear Space to XWalk (in)	N/A
N/A	Any Obstructions?	N/A	N/A	Storm Grate/Utility Hazard?	N/A
	Obstruction Type			Storm Grate/Utility Type	
		N/A			N/A
			Yes	Surface Condition? (G/P)	Good

Remove & Replace Curb Ramp With Two New Directional Ramps or Equivalent.
