Access Compliance Report

Public Rights-of-Way (Curb Ramps)

Intersection ID: 46918	Main Street: BLUE_ASH_LN	Cross Street: PONDEROSA_PINE_LN	Location: SW
ADA ID: 2A1D5B8ACE95	Ramp Type: Perp	Initial Pass/Fail: Fail	Overall Compliance: No
		Severity Score: 25

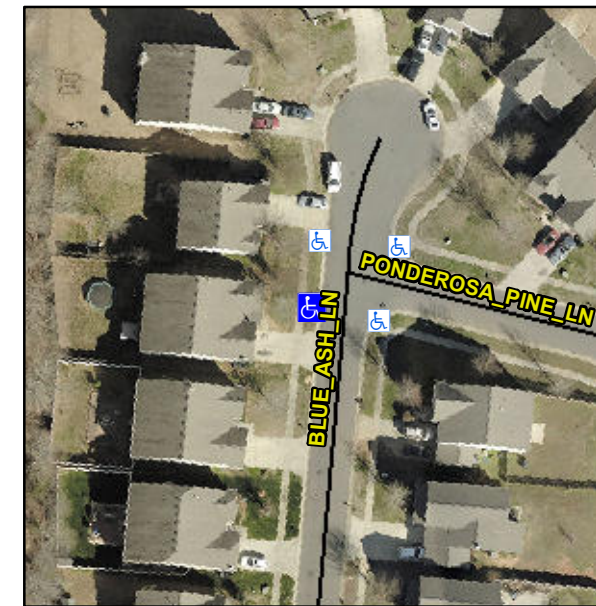
Not Found, R304.2.2, R304.5.3

Compliance	Description	Data	Compliance	Description	Data
N/A	Ramp Length (in)	84.0	No	Ramp Slope (%)	10.3
Yes	Ramp Width (in)	48.0	No	Ramp XSlope (%)	5.4
N/A	Flare Type LT	N/A	N/A	Flare Type RT	N/A
N/A	Flare Slope LT (%)	N/A	N/A	Flare Slope RT (%)	N/A
N/A	Flare Traversable LT?	N/A	N/A	Flare Traversable RT?	N/A
N/A	Landing Length (in)	N/A	N/A	DWS Provided?	N/A
N/A	Landing Width (in)	N/A	N/A	DWS Contrast?	N/A
N/A	Landing Slope (%)	N/A	N/A	DWS Length (in)	N/A
N/A	Landing X Slope (%)	N/A	N/A	DWS Full Width?	N/A
N/A	Landing Curb? (Y/N)	N/A	N/A	DWS Offset (in)	N/A
N/A	Shared Landing?	N/A			
N/A	Gutter Ponding?	N/A	N/A	Gutter Slope (%)	N/A
N/A	Gutter Lip Ht (in)	N/A	N/A	Gutter X Slope (%)	N/A
N/A	Painted X Walk1?	No	N/A	Painted X Walk2?	N/A
	X Walk 1 Direction	To E		X Walk 2 Direction	N/A
N/A	X Walk 1 Width (in)	N/A	N/A	X Walk 2 Width (in)	N/A
	X Walk 1 Slope (%)	1.3		X Walk 2 Slope (%)	N/A
	X Walk 1 X Slope (%)	6.2		X Walk 2 X Slope (%)	N/A

N/A	Ramp inside XWalk1?	N/A	N/A	Ramp inside XWalk2?	N/A
	Road Slope (%)	N/A	N/A	Clear Space?	N/A
	Road X Slope (%)	N/A	N/A	Clear Space to XWalk (in)	N/A
N/A	Any Obstructions?	N/A	N/A	Storm Grate/Utility Hazard?	N/A
	Obstruction Type			Storm Grate/Utility Type	
		N/A			N/A
			Yes	Surface Condition? (G/P)	Good

Remove & Replace Entire Ramp.
