# Access Compliance Report

## Public Rights-of-Way

### (Curb Ramps)

| Intersection ID: 6961 | Main Street: CEDARHURST_DR | Cross Street: PINELEAF_DR | Location: | S |

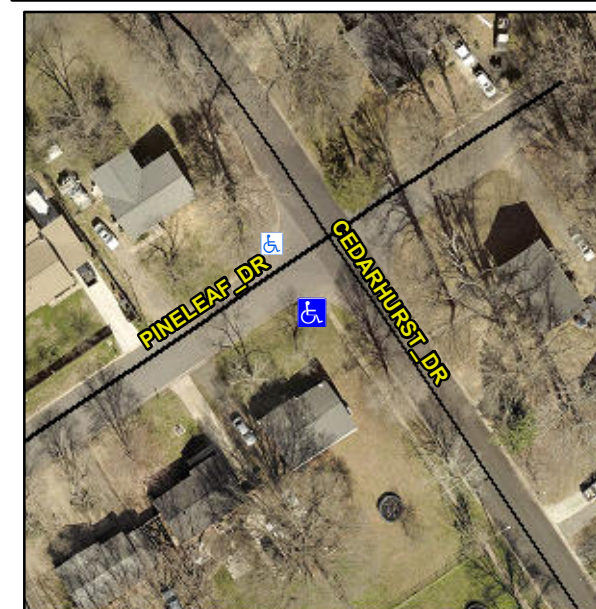
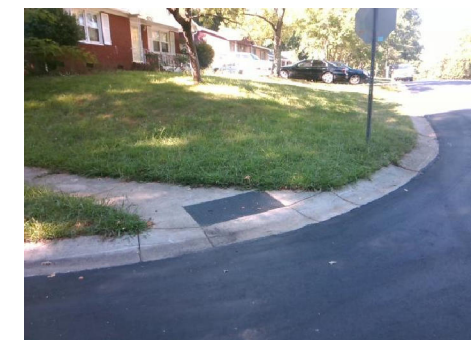
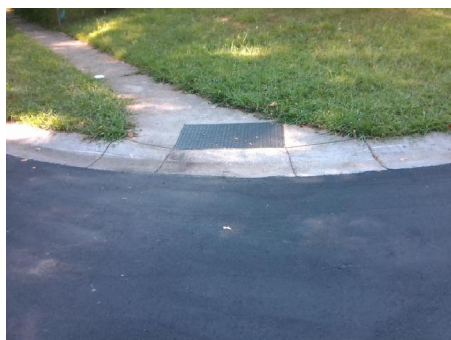
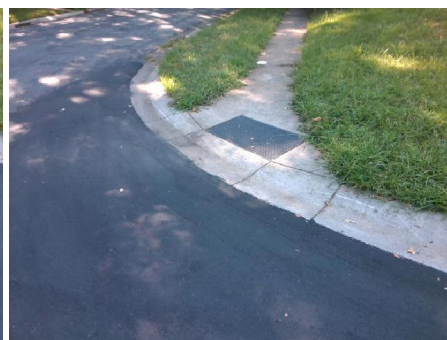
| ADA ID: 2A1E3894864B | Ramp Type: Directional | Initial Pass/Fail: Fail | Overall Compliance: No | Severity Score: 13.75 |

**R304.2.2, R304.5.3**

| Compliance | Description | Data | Compliance | Description | Data |
|---|---|---|---|---|---|
| No | Ramp Slope (%) | 9.8 | N/A | Grade Break XSlope (%) | 0.0 |
| No | Ramp XSlope (%) | 4.8 | | | |

**Remove & Replace Entire Ramp.**
