Access Compliance Report

Public Rights-of-Way

(Curb Ramps)

Intersection ID: 3893	Main Street: DANIELLE CHRISTINA CT	Cross Street: OVERLOOK COVE RD	Location: SW
ADA ID: 2A209E2B5302	Ramp Type: Perp	Initial Pass/Fail: Fail	Overall Compliance: No
Severity Score: 22.5			
Codes/Mitigation Info/Possible Solution		Field Measurements/Component Compliance

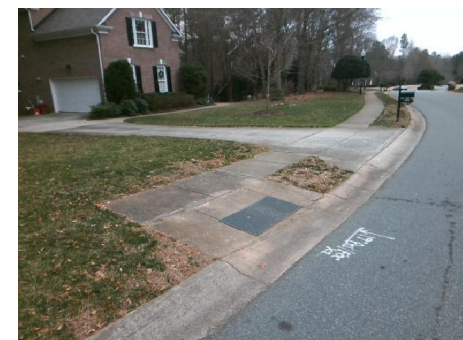
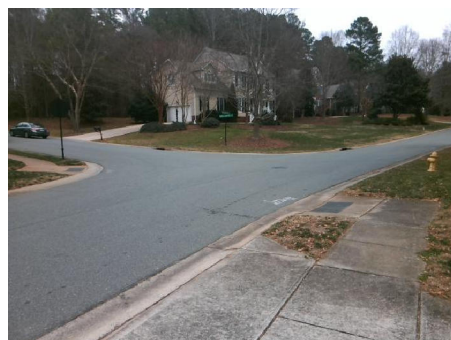
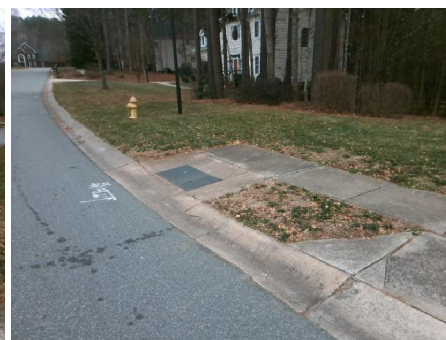
Not Found, R304.5.1, R304.2.2, R304.5.3

Compliance	Description	Data	Compliance	Description	Data
N/A	Ramp Length (in)	49.0	No	Ramp Slope (%)	8.6
No	Ramp Width (in)	46.0	No	Ramp XSlope (%)	3.0
N/A	Flare Type LT	N/A	N/A	Flare Type RT	N/A
N/A	Flare Slope LT (%)	N/A	N/A	Flare Slope RT (%)	N/A
N/A	Flare Traversable LT?	N/A	N/A	Flare Traversable RT?	N/A
N/A	Landing Length (in)	N/A	N/A	DWS Provided?	N/A
N/A	Landing Width (in)	N/A	N/A	DWS Contrast?	N/A
N/A	Landing Slope (%)	N/A	N/A	DWS Length (in)	N/A
N/A	Landing X Slope (%)	N/A	N/A	DWS Full Width?	N/A
N/A	Landing Curb? (Y/N)	N/A	N/A	DWS Offset (in)	N/A
N/A	Shared Landing?	N/A			
N/A	Gutter Ponding?	N/A	N/A	Gutter Slope (%)	N/A
N/A	Gutter Lip Ht (in)	N/A	N/A	Gutter X Slope (%)	N/A
N/A	Painted X Walk1?	No	N/A	Painted X Walk2?	N/A
	X Walk 1 Direction	To N		X Walk 2 Direction	N/A
N/A	X Walk 1 Width (in)	N/A	N/A	X Walk 2 Width (in)	N/A
	X Walk 1 Slope (%)	3.7		X Walk 2 Slope (%)	N/A
	X Walk 1 X Slope (%)	2.6		X Walk 2 X Slope (%)	N/A

N/A	Ramp inside XWalk1?	N/A	N/A	Ramp inside XWalk2?	N/A
	Road Slope (%)	N/A	N/A	Clear Space?	N/A
	Road X Slope (%)	N/A	N/A	Clear Space to XWalk (in)	N/A
N/A	Any Obstructions?	N/A	N/A	Storm Grate/Utility Hazard?	N/A
	Obstruction Type			Storm Grate/Utility Type	
		N/A			N/A
			Yes	Surface Condition? (G/P)	Good

Possible Solutions:

Remove & Replace Entire Ramp.
