# Access Compliance Report

## Public Rights-of-Way

| Intersection ID: 32248 | Main Street: DENNINGTON GROVE LN | Cross Street: WESTGARTH AV | Location: E |
| ADA ID: 2A21CB479B1C | Ramp Type: BlendTrans1 | Initial Pass/Fail: Pass | Overall Compliance: No |

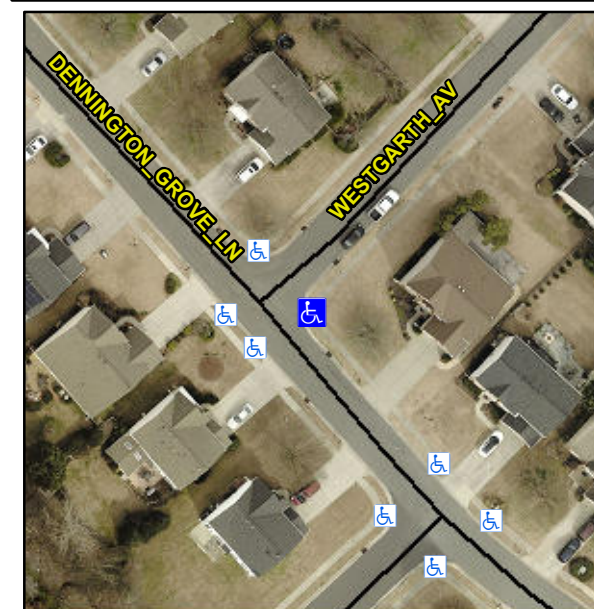
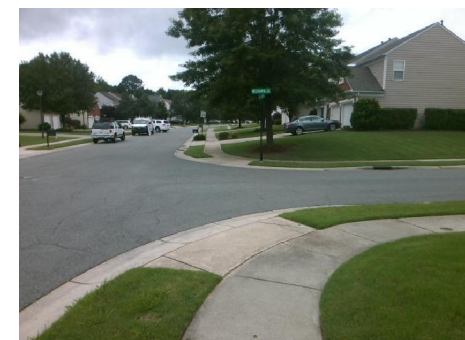
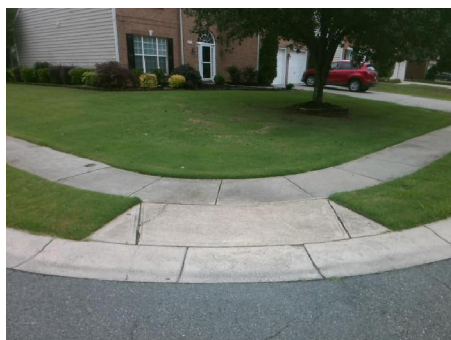
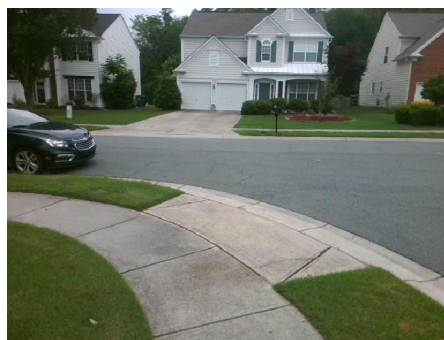
| Severity Score: 15 | | | |

**Not Found, R304.2.1, R305, R304.5.4**

| Compliance | Description | Data | Compliance | Description | Data |
|---|---|---|---|---|---|
| No | Landing Length (in) | 47.0 | No | DWS Provided? | No |
| Yes | Gutter Ponding? | No | No | Gutter Slope (%) | 5.9 |
| | | | No | Curb Slope (%) | 18.0 |

**Remove & Replace Curb Ramp With Two New Directional Ramps or Equivalent. Remove & Replace Gutter.**
