# Access Compliance Report

## Public Rights-of-Way

| Intersection ID: 20599 | Main Street: CARMEL_RD | Cross Street: CARMEL_PARK_LN | Location: SE |
| ADA ID: 2A24A3B60AD4 | Ramp Type: PerpDiag | Initial Pass/Fail: Fail | Overall Compliance: No |

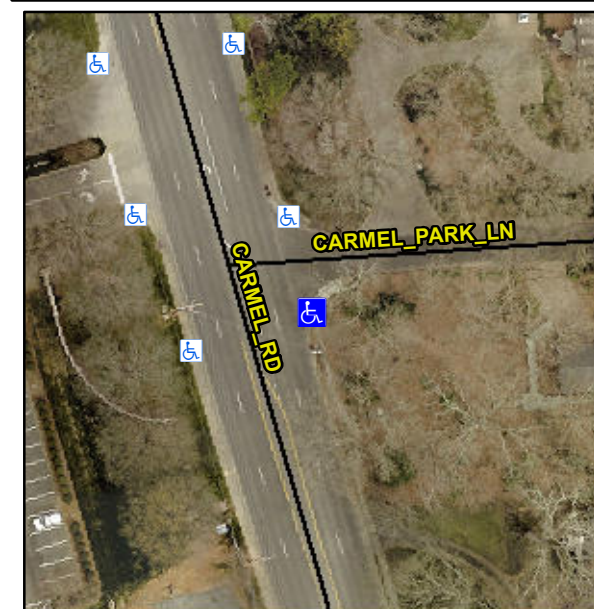
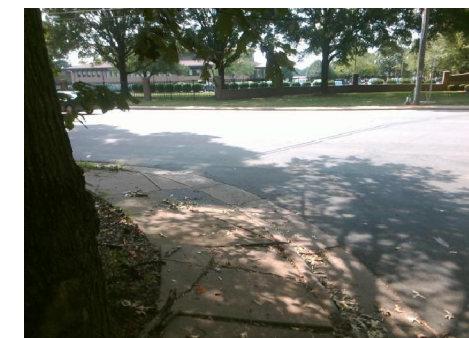
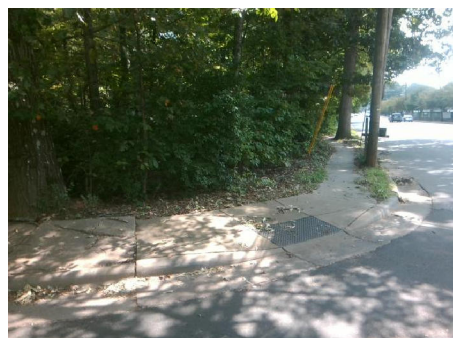
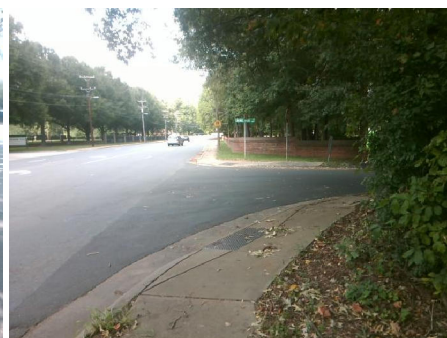
| Severity Score: 26.25 | | | |

**Not Found, R304.2.2, R304.5.3**

| Compliance | Description | Data | Compliance | Description | Data |
|---|---|---|---|---|---|
| N/A | Ramp Length (in) | 61.0 | No | Ramp Slope (%) | 12.8 |
| Yes | Ramp Width (in) | 48.0 | No | Ramp XSlope (%) | 4.1 |

**Remove & Replace Curb Ramp With Two New Directional Ramps or Equivalent.**

Total Cost: \$ 3200.00
