# Access Compliance Report

## Public Rights-of-Way

### (Curb Ramps)

| Intersection ID: 43646 | Main Street: CEDAR_CROSSINGS_DR | Cross Street: CALLOW_FOREST_DR | Location: SW |

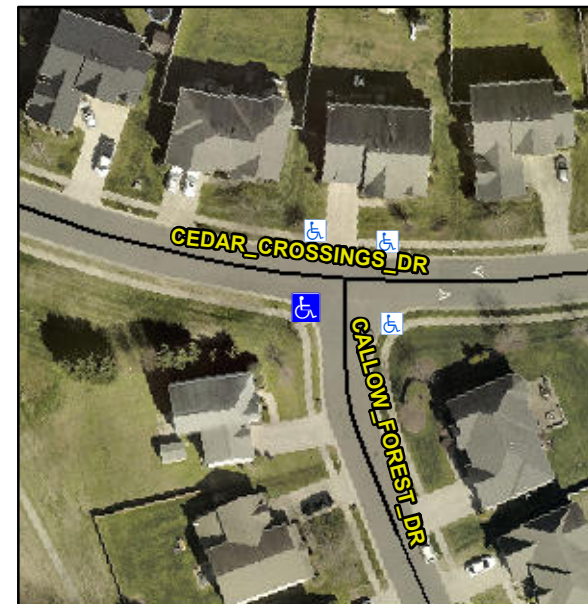
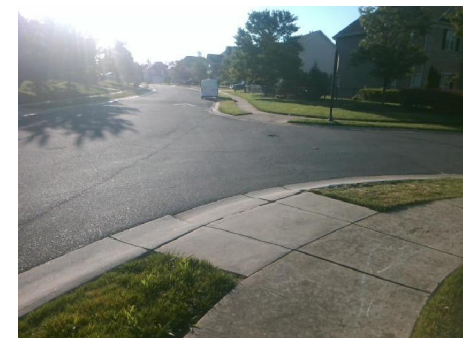
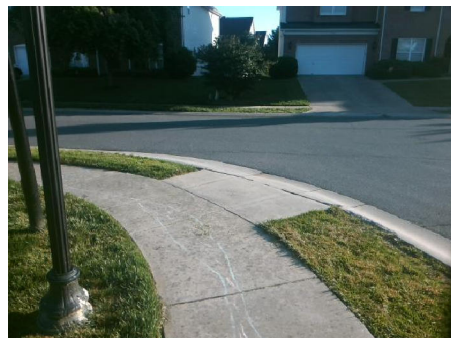
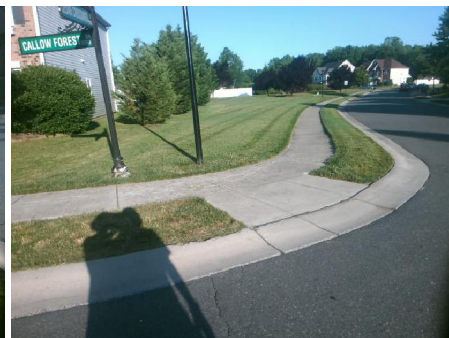
| ADA ID: 2A2752AE83C7 | Ramp Type: PerpDiag | Initial Pass/Fail: Fail | Overall Compliance: No |
| Severity Score: 10 | | | |

**Not Found, R304.5.1, R304.5.3**

| Compliance | Description | Data | Compliance | Description | Data |
|---|---|---|---|---|---|
| N/A | Ramp Length (in) | 48.0 | Yes | Ramp Slope (%) | 7.0 |
| No | Ramp Width (in) | 40.0 | No | Ramp XSlope (%) | 2.7 |

**Remove & Replace Curb Ramp With Two New Directional Ramps or Equivalent.**

Total Cost: \$ **3200.00**
